| REPORT OF | MEETING | DATE | ITEM NO |
|---|---|---|---|
| DEVELOPMENT SERVICES DIRECTORATE | OPERATIONAL MANAGEMENT COMMITTEE | 9 NOVEMBER 2021 | 9 |
| LYTHAM SEA DEFENCE REPAIRS | | | |

The length of the seawall in Lytham, from Church Scar to the Windmill, requires remedial work to the concrete upstand upon which the railings are fixed to. There is a length of the upstand near Windmill of approximately 65m that has significantly moved and consequently, the railings are now at an angle. The report considers the remedial works for the existing seawall at Lytham and a proposal to replace a length with new railings.

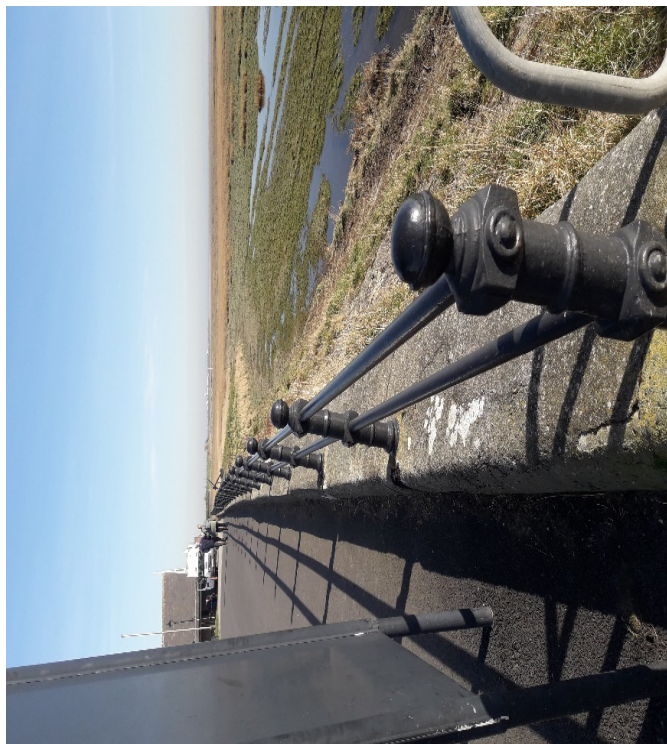
- Images 1 and 2 (attached) show the concrete upstand that requires remedial work. At various points along the upstand, work is required to repair areas of spalling. Historically, patch repairs have been undertaken to this detail where concrete spalling is evident - caused by surface water, frost and a coastal environment. In addition, a length of the upstand and railings have all moved. Image 3 shows this detail is absent on the new promenade from Church Scar to Granny's Bay.

5. A 65m length of the upstand has failed near to the Windmill. The concrete upstand is not ideal as surface water on the promenade runs towards the upstand but cannot drain away. Subsequently over time, surface water has found a route under the upstand and thus undermining the foundation. To demolish the old upstand and replace it with the same detail would, in officer opinion, be a poor use of money. In addition, the current height of the railings does not comply with safety regulations so need raising.
6. A design has been proposed that will address the drainage issue. This design will also replicate the railings seen west of Church Scar. This will also allow Technical Services the opportunity to raise the height of the railings and improve safety - see image 3. This work will be tendered and is expected to be delivered late winter/early spring 2022.

Image 1 - Existing plinth wall which is leaning seaward adjacent the windmill.

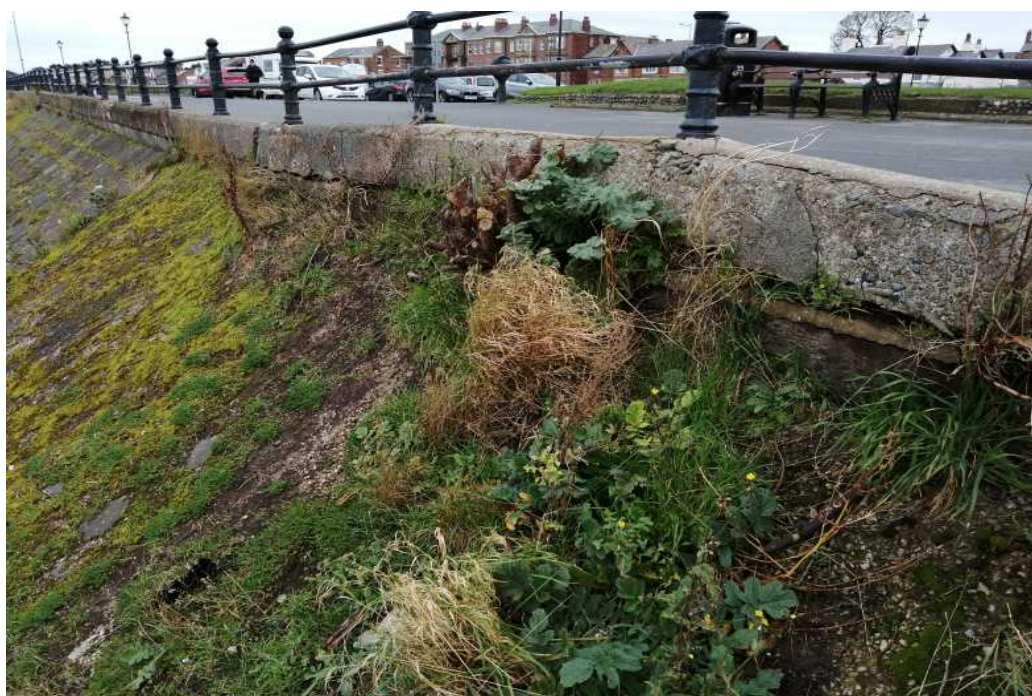
7. The surface water, in addition to undermining the plinth wall foundation, is finding numerous paths into the stone revetment via capillary action. Over time, vegetation has started to grow a root system into the revetment which, if not addressed in an appropriate manner, will undermine the structural integrity of the structure - see image 2.
8. The woody vegetation along the sea wall has been stump treated to try and suppress future growth. These works were carried out by the Ranger Team, under the supervision of the Council's Parks Department.
9. Future control measures of vegetation along the revetment are currently being explored to ensure the sea wall structure is not compromised, whilst recognising its importance as a wildlife habitat.

Image 2 - Existing plinth wall being undermined by vegetation

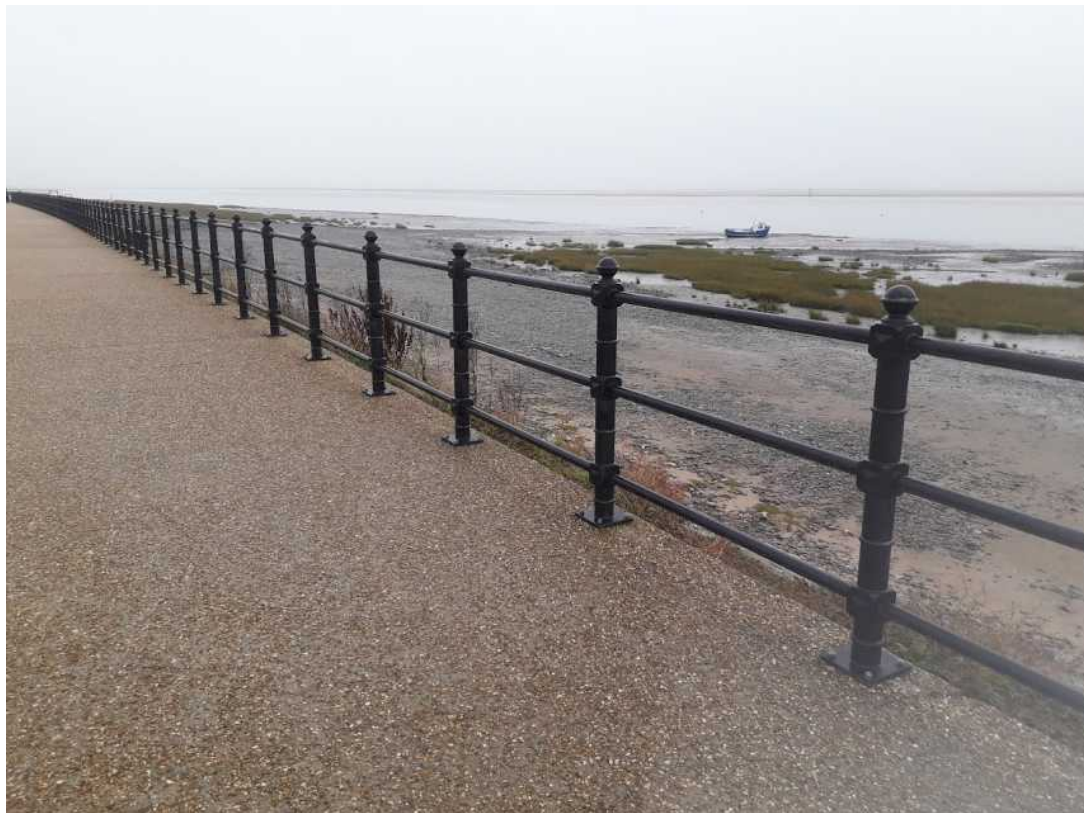
Image 3 - Proposed replacement detail – as delivered west of Church Scar. Note the old stone revetment has been retained in this area.
