Kirkham Rural Splash

Station Road
Kirkham
Preston
PR4 2HA

Mechanical & Electrical Engineering Services Condition Report & Options Appraisal

REVISION HISTORY			Ref.	1367-R01
Rev.	Author	Checked By	Date	Comments / Status
01	Steven Walley (Mech) Jonathan Baron (Elec)	N/A	04/03/24	First issue.
02	Steven Walley (Mech) Jonathan Baron (Elec)	N/A	20/03/24	Second issue.
03	Steven Walley (Mech) Jonathan Baron (Elec)	N/A	26/03/24	Third issue.
04	Steven Walley (Mech) Jonathan Baron (Elec)	N/A	03/04/24	Fourth issue.

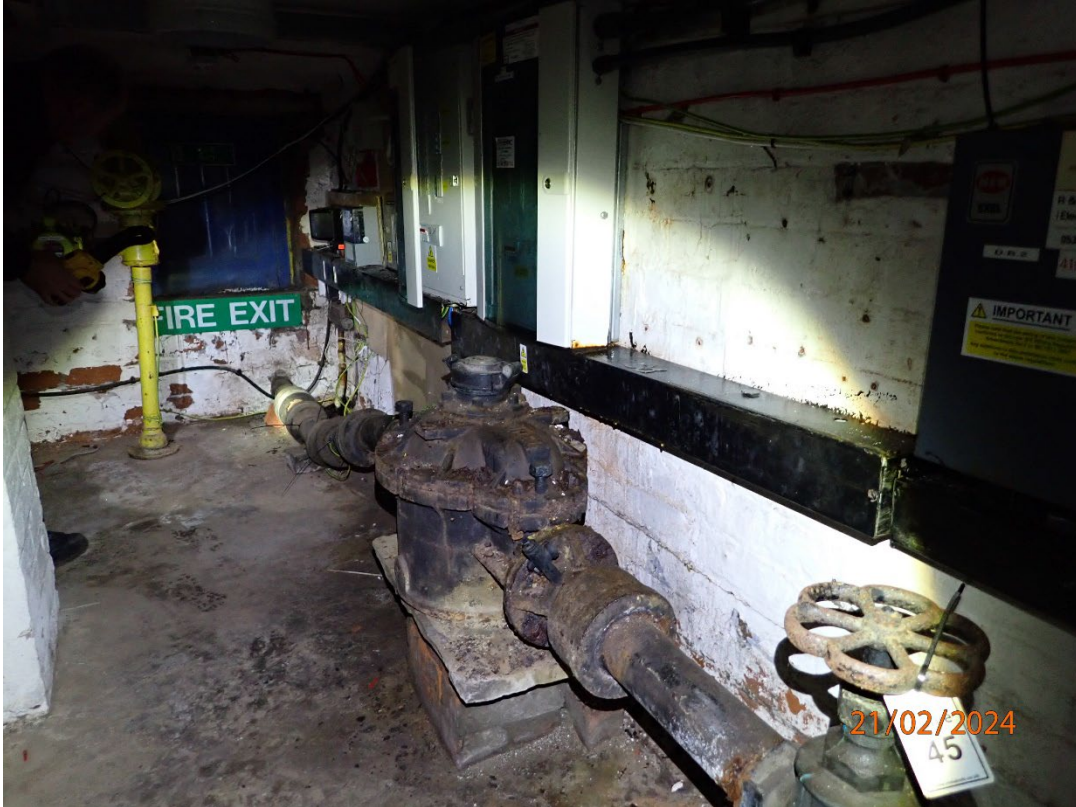
Utility Company's Mains Cold Water Meter Assembly

The inlet to the meter is fitted with a gate valve. The outlet is fitted with a gate valve. There are no draincocks, double check valves, pressure gauges or pressure reducing valves fitted.

The cold-water pipework appears to be a mixture of cast iron (lead caulked joints to fittings), galvanised mild steel, with significant signs of corrosion. None of the pipework is thermally insulated or trace heated.

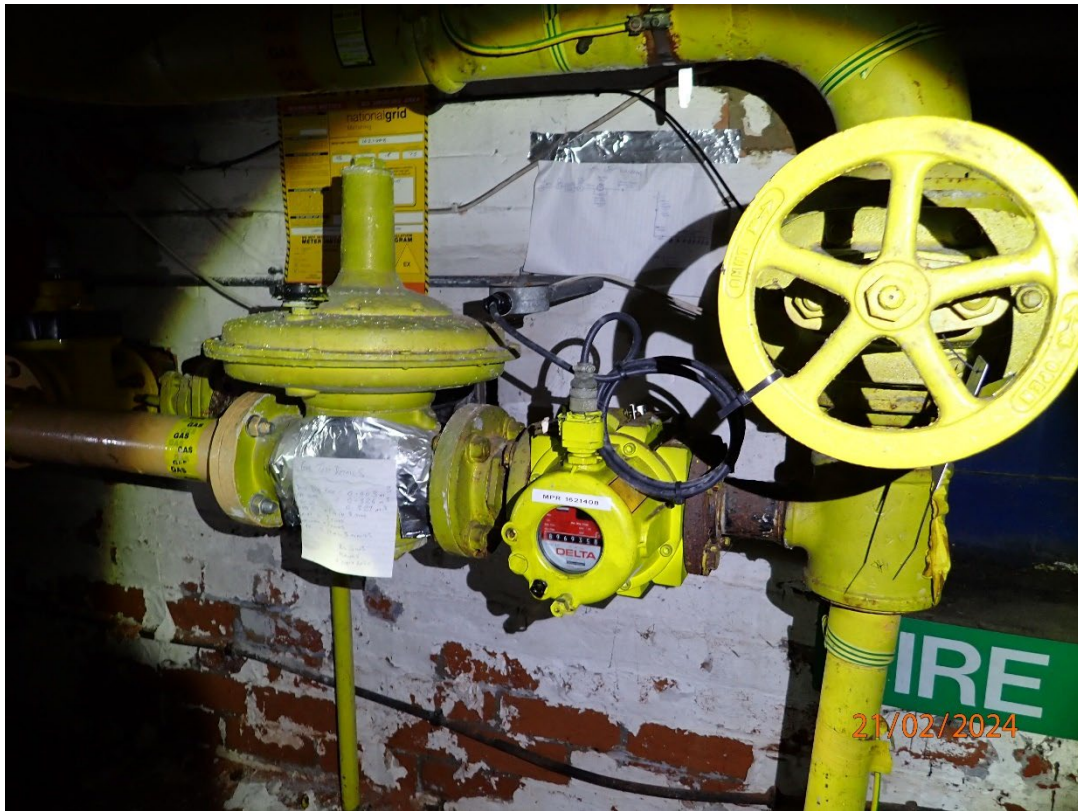
Utility Company's Natural Gas Service Governor & Meter Assembly

The meter is a Schlumberger Delta D3 with a rated maximum capacity of 84.95m³/hour. The MPRN reference is stated as 1621408 (this has not been verified with the Utility Company). The meter is complete with inlet emergency control valve (manually operated), governor and pulsed output module. The meter assembly is shown below: -

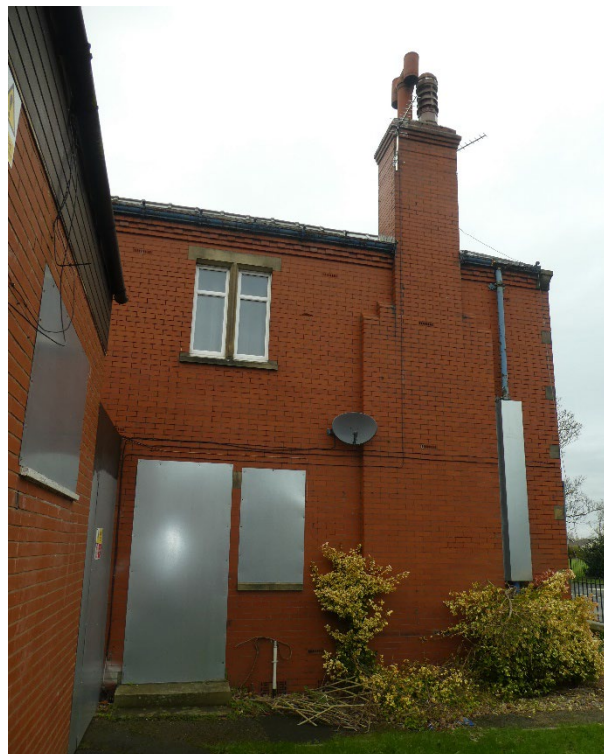
Incoming Natural Gas Service to Two-Storey "House" Area

A further incoming natural gas service enters the two-storey "house" area of the building. The incoming service pipe routed below ground rises to enter the building through the external wall at low level. We were unable to access this area of the building for safety reasons. We are led to believe that this gas service supplies a domestic-style boiler.

A further incoming natural gas service enters the two-storey” house” area of the building. We were unable to access this area of the building for safety reasons. We are led to believe that this gas service supplies a domestic-style boiler. We would recommend that this service is stripped out and the services replaced to suit.

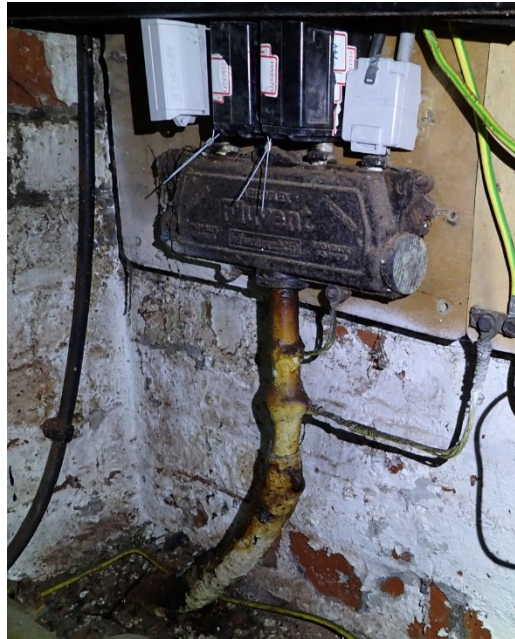
The Internal electrical cutout is shown below: -

It was noted the overall condition of the existing electrical cutout was poor and it was badly corroded as such if the existing supply is to be re-used an application request should be made to replace the old cutout and cable for new. This is often done by the DNO at nil cost however and application must be made to confirm this.

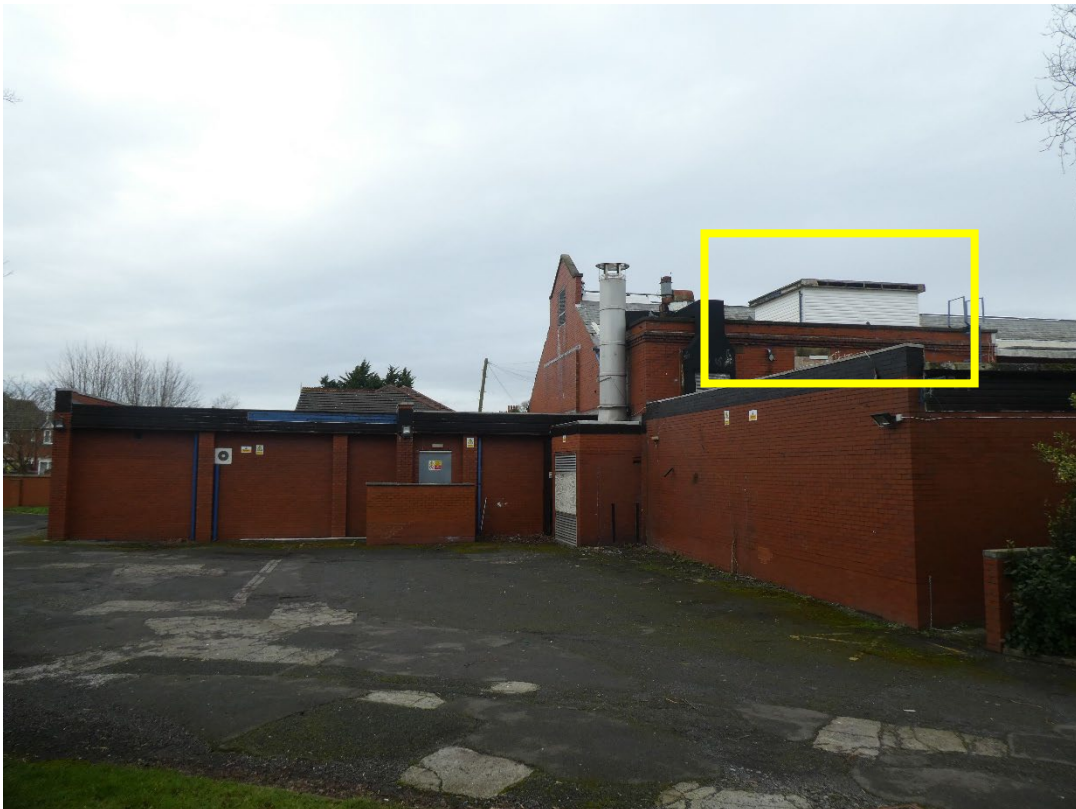
We could not locate any potable cold water storage cisterns. We are led to believe that these may be located in a rooftop enclosure, positioned above the Boiler house; however, this could not be accessed for safety reasons.

Rooftop Enclosure for Potable Cold Water Storage Cistern(s)
Enclosure Clad in White Panelling (Highlighted in Yellow Box)

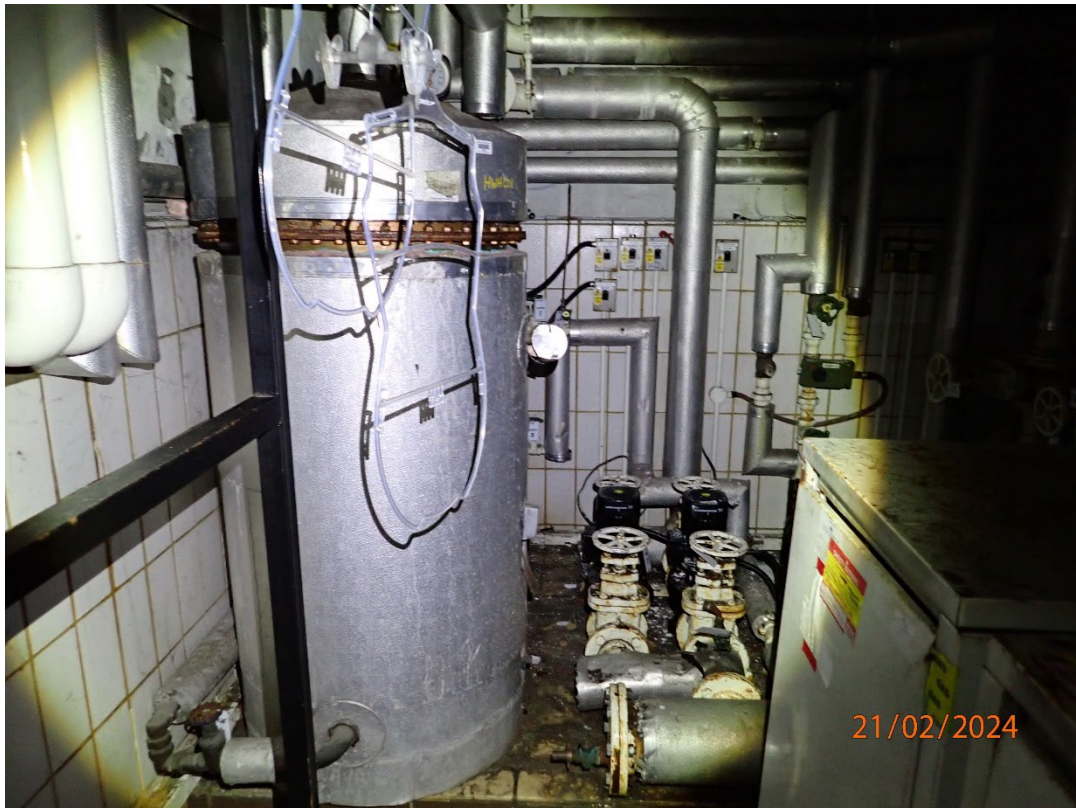
HWS Storage Calorifier

Domestic hot water is generated by a vented, indirect, copper, cylindrical, vertical pattern calorifier, located in the Boiler house. The calorifier is approximately 1m diameter x 2m tall, giving a capacity of 1,500 litres or thereabouts. No manufacturer's data plate is visible. The calorifier is thermally insulated and clad in stucco-embossed aluminium sheeting.

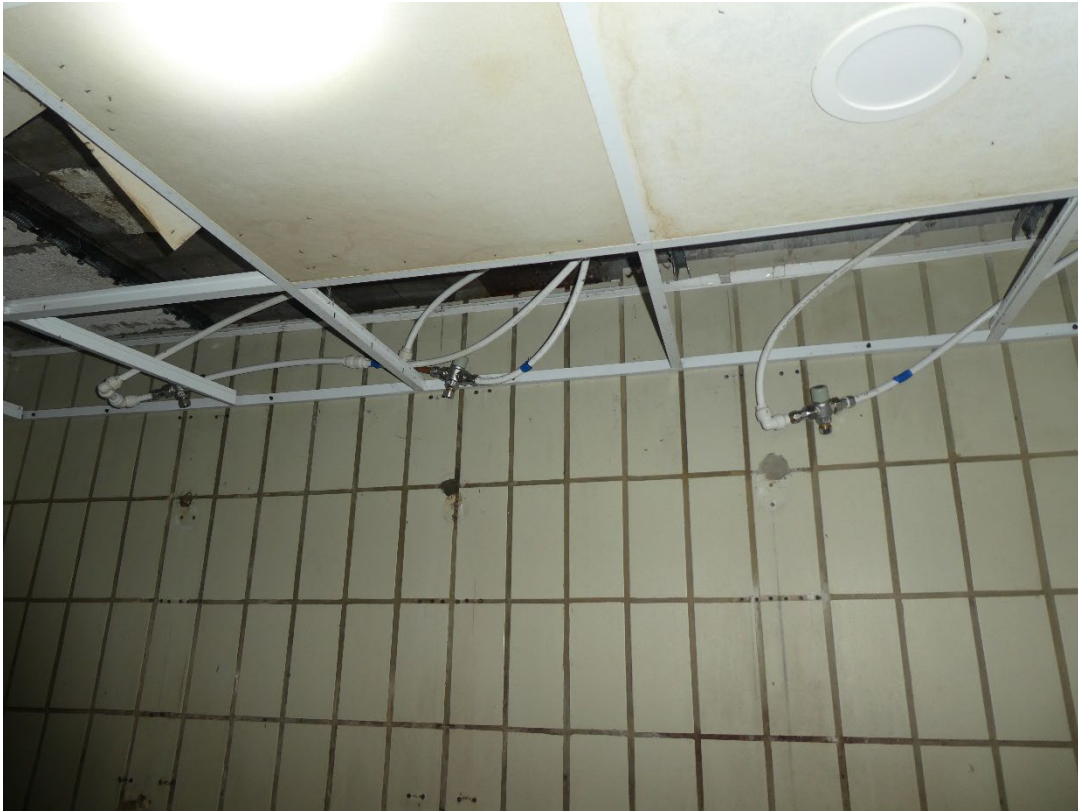
Changing Area Thermostatic Showers (Stripped Out)

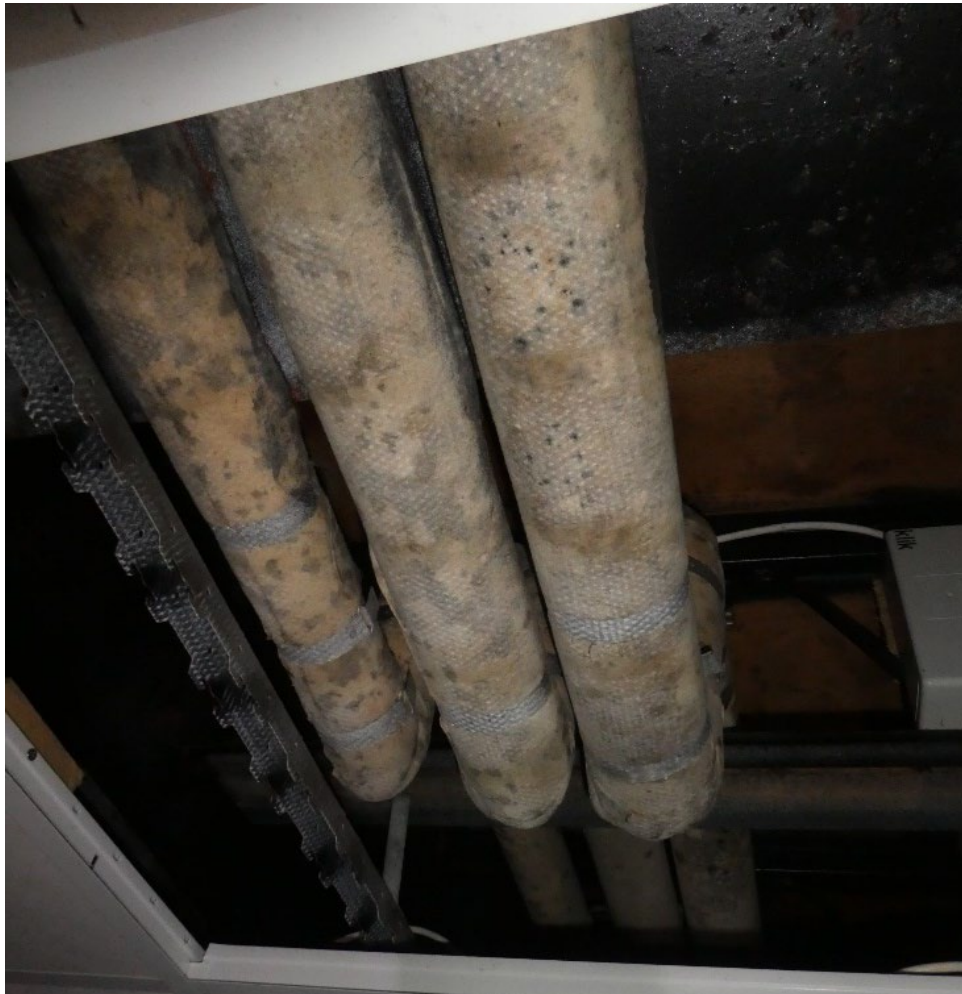
For services routed within the general areas of the building (Reception, staff areas, changing rooms etc.), there are no obvious visual signs of damage, or deterioration above and beyond what would be expected for services of their age. Our survey did not reveal building fabric, fixtures and/or fittings which had been damaged by water leakage. The services within the pool undercroft and Boiler house certainly show signs of age and deterioration.

Typical Pipework Installation in Ceiling Void

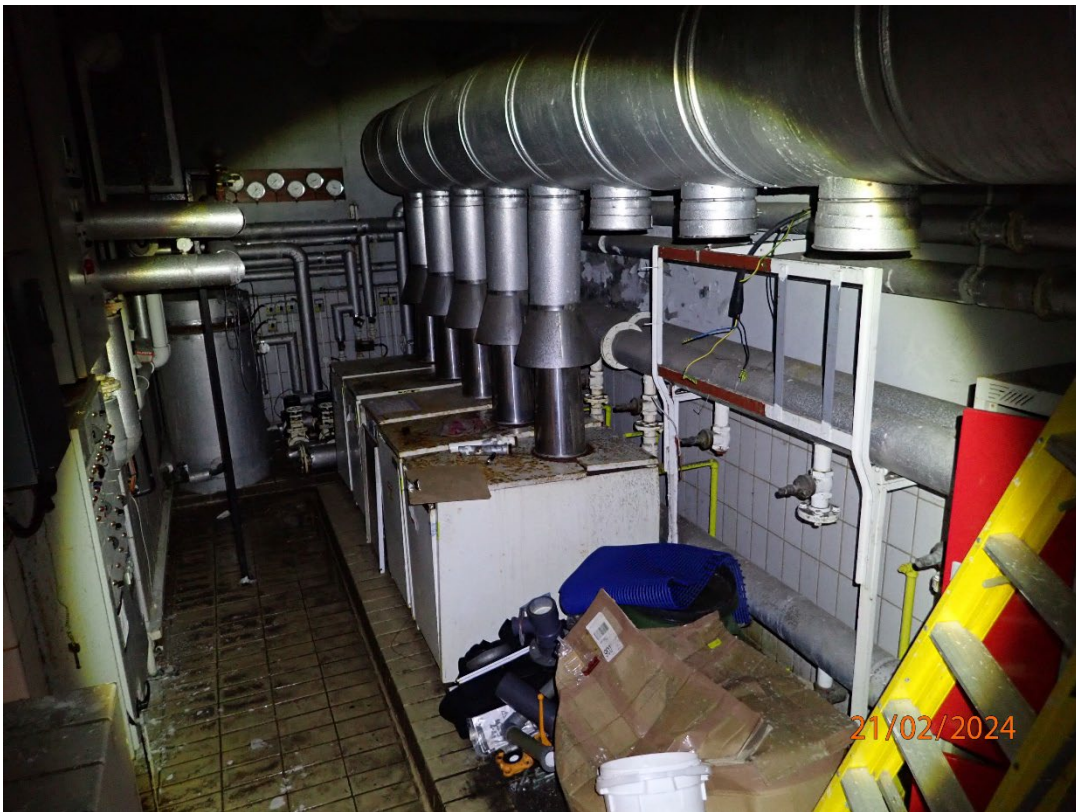
LTHW Boiler Plant

Significant areas of rust are present on every boiler casing panel. Some panels have been removed or have fallen off.

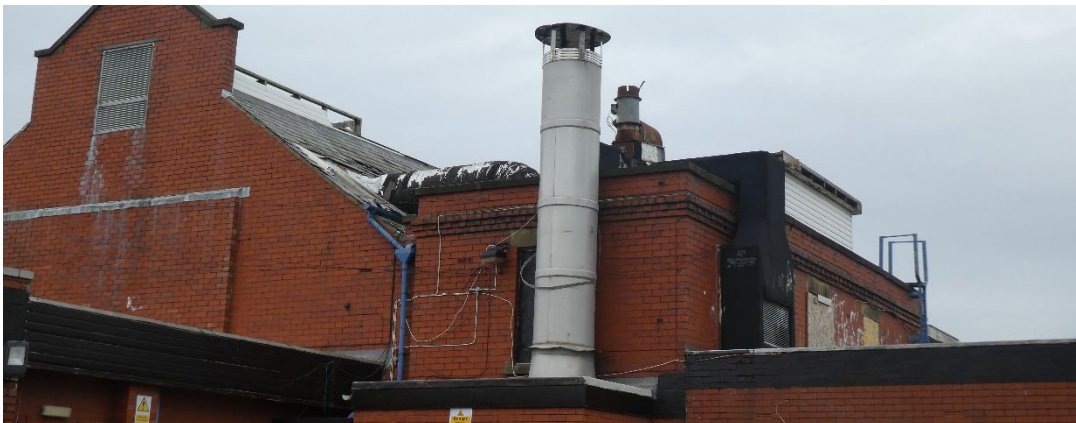
LTHW Boiler Plant Combustion Exhaust Flue

Products of combustion from the boilers are discharged to atmosphere at roof level via a combined atmospheric flue. We presume that the flue routed externally used to serve a coal-fired boiler plant, since it is much larger in size than the header in the Boiler house.

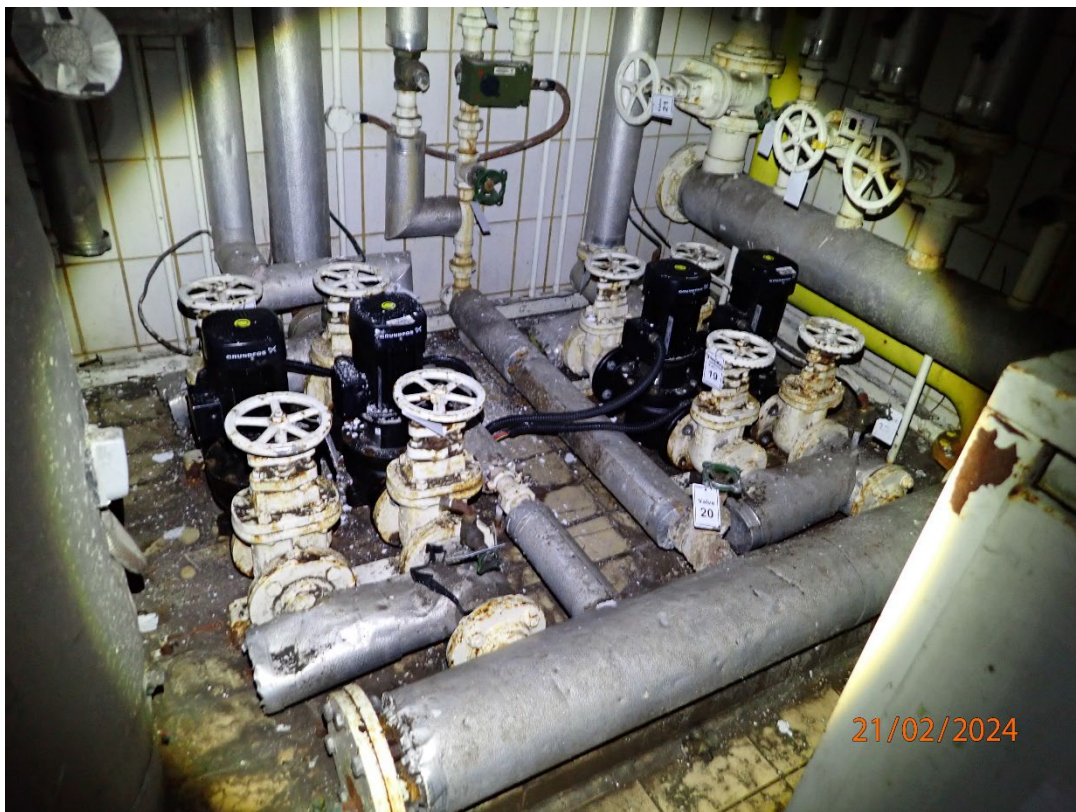
Typical Heating System Pumps

It is evident that the original pumps have been replaced at some point with newer Grundfos models. There are no obvious visual signs of damage, or deterioration above and beyond what would be expected for pumps of this age.

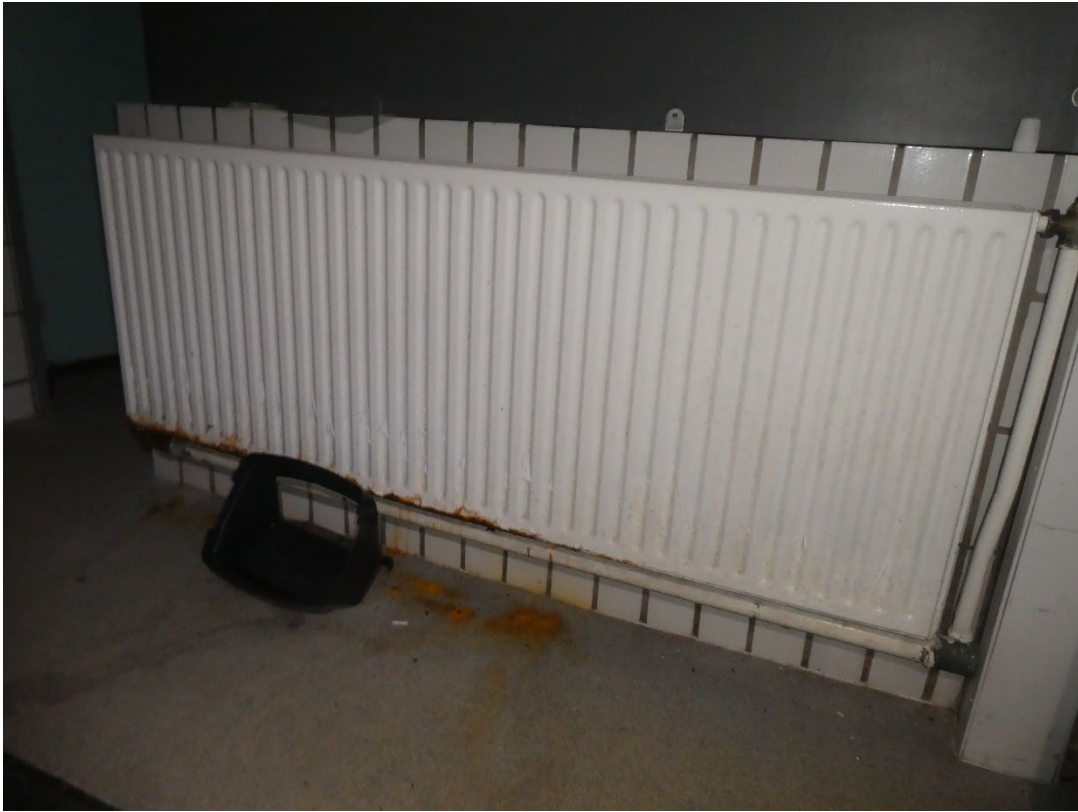
Radiators are pressed steel panel types, the majority being cased double-panel types, with some triple panel types. Some of the radiators have been painted silver. Pipe connections are generally top-bottom-opposite-end, with manual valves (no thermostatic types). The radiators in wet areas, such as changing rooms, are showing signs of corrosion, particularly along the bottom welded seams.

Typical Pressed Steel Panel Radiator (Rust along Bottom Edge)

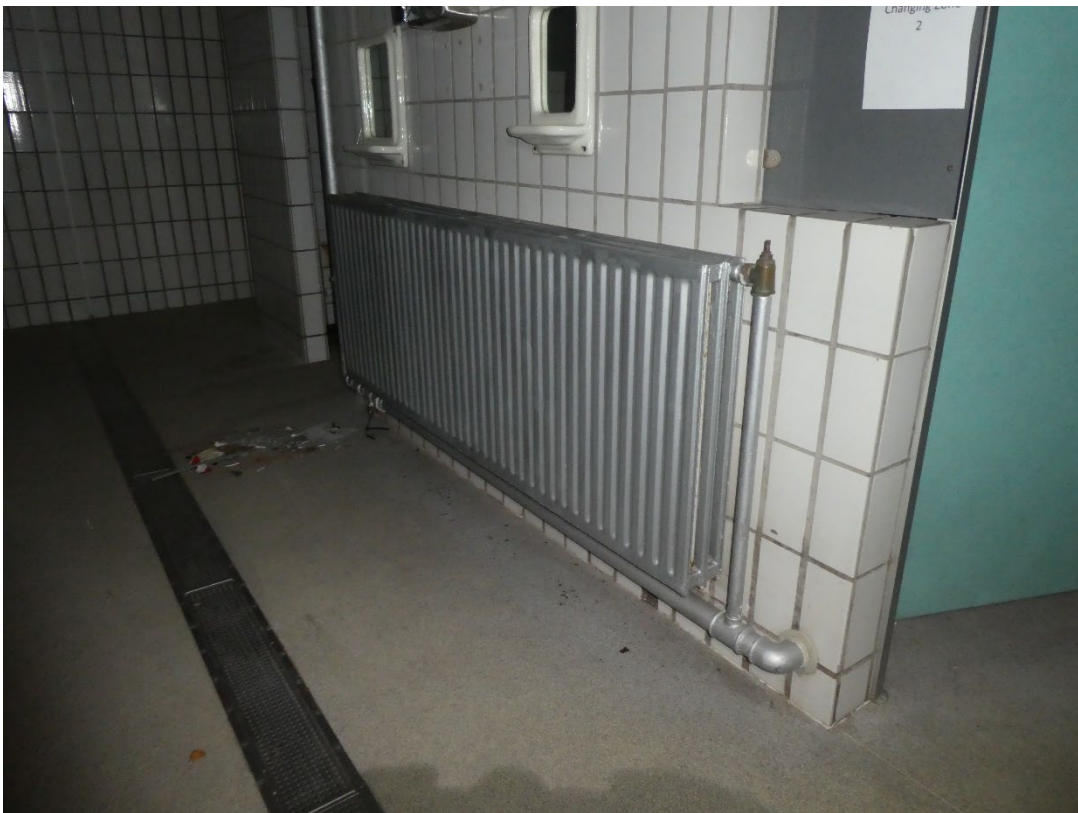
Typical Pressed Steel Panel Radiator (Painted Silver)

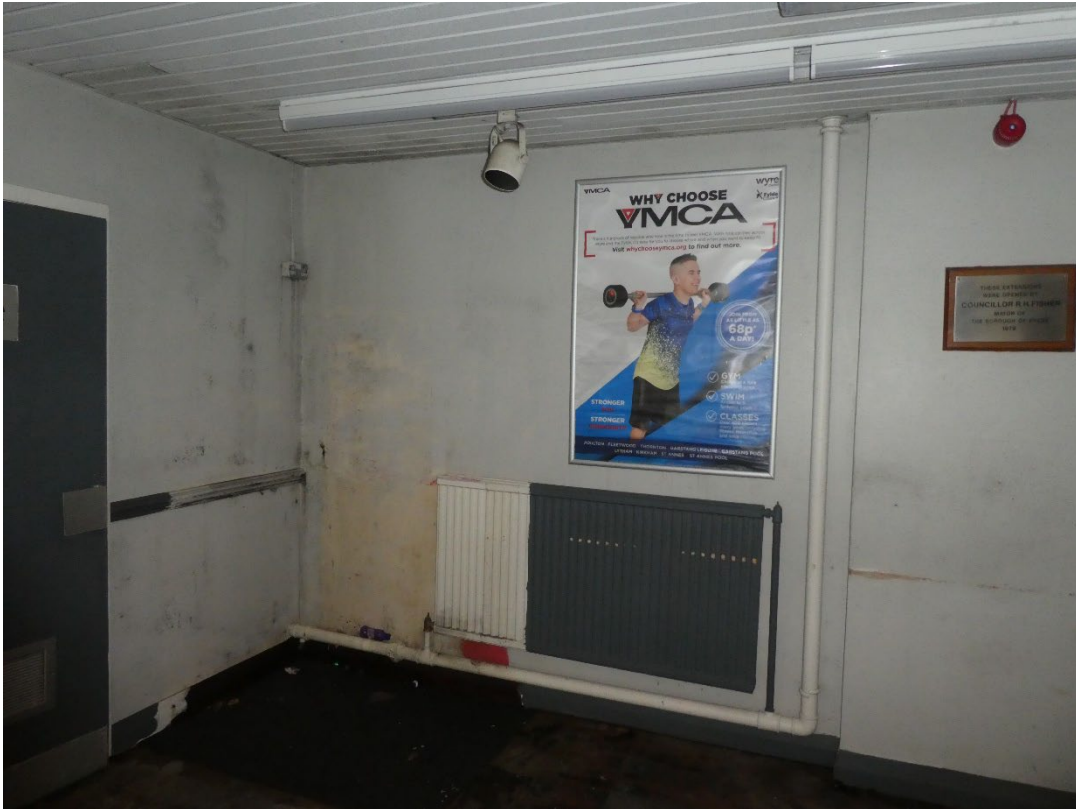
Typical Single-Pipe Heating Distribution

single-pipe distribution type, utilising a series of large-bore pipes to serve the various radiators and pipe heating cold. This type of distribution has rarely been used for the last 30 years, since it is costly to install, limits the choice and location of heat emitters and is considered unsightly.

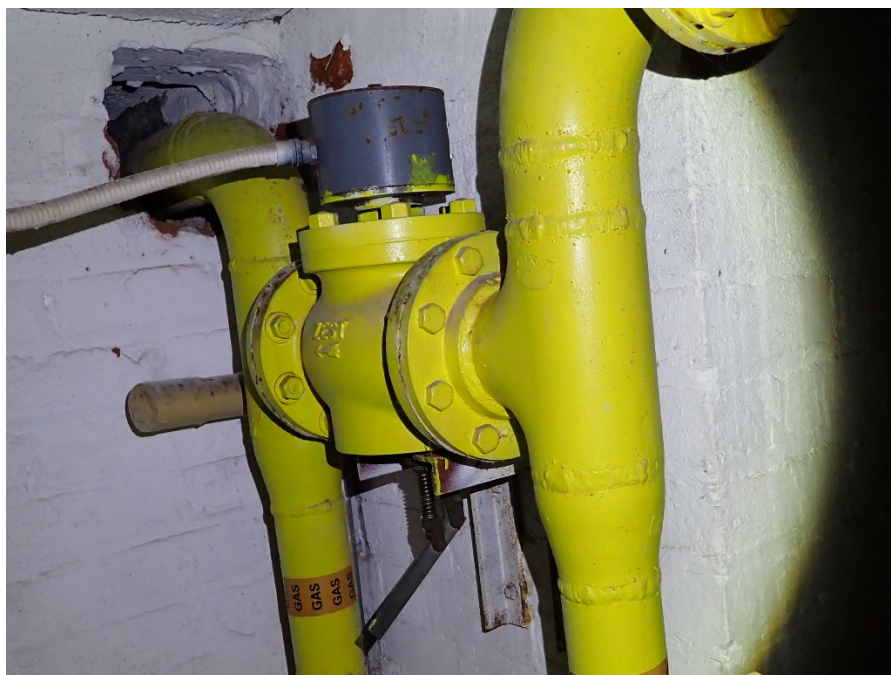
Gas Solenoid Valve

The pipework is generally mild steel with welded and flanged joints on large-bore and screwed joints on small-bore. The pipework shows some signs of corrosion.

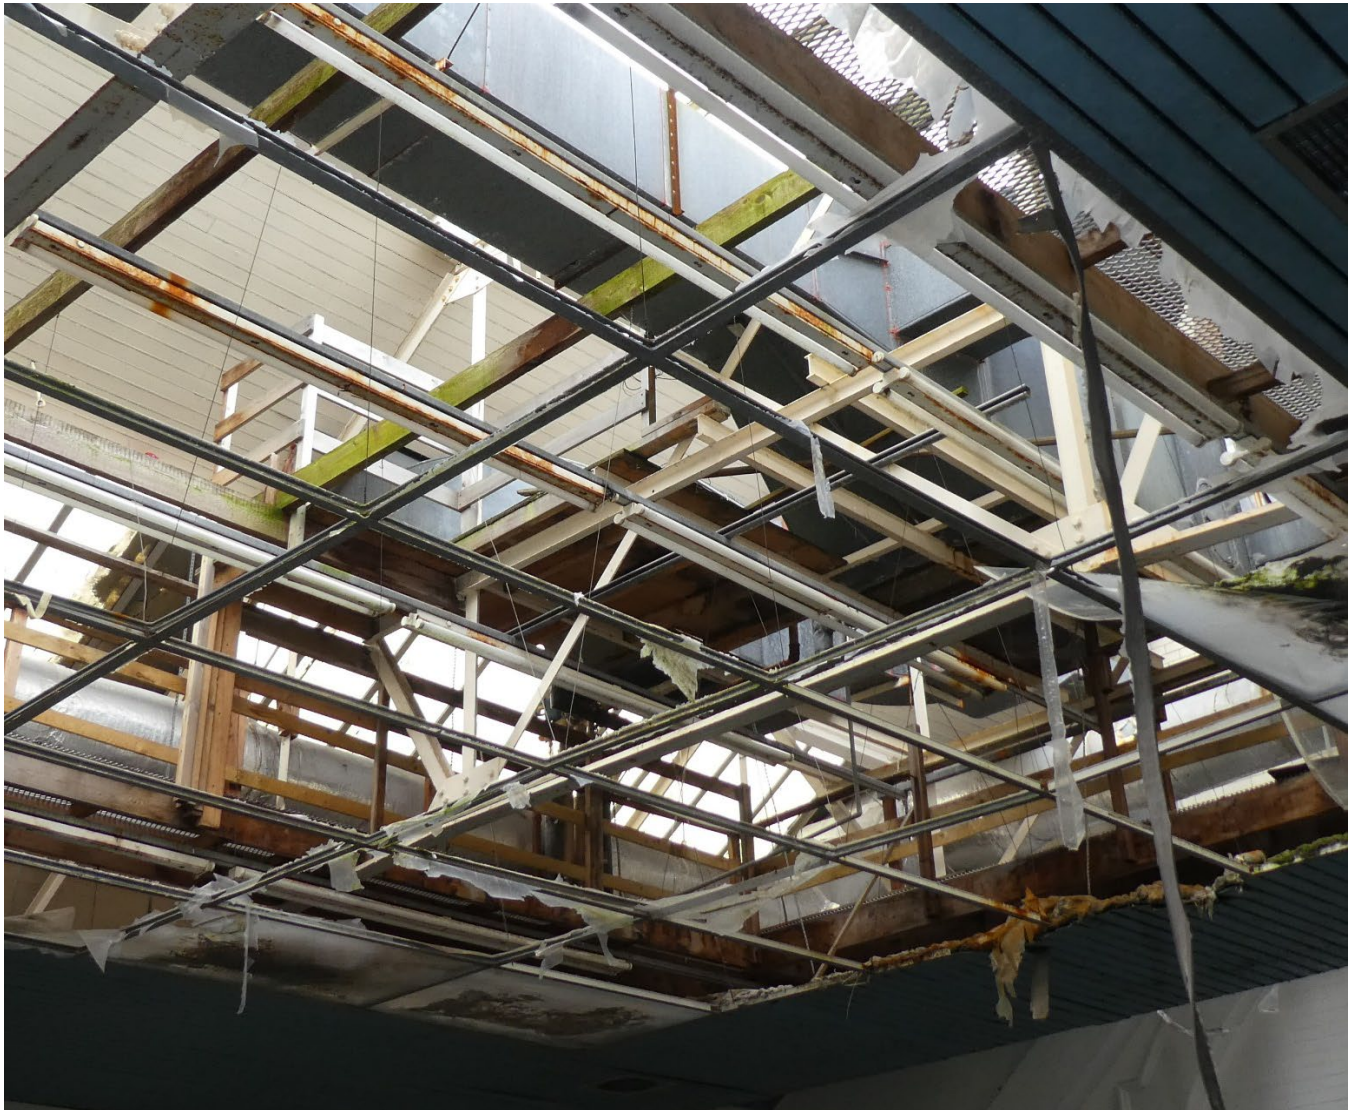
Pool Area AHU

Significant corrosion is evident on the panels of the AHU, even when viewed from floor level. The unit has been exposed to weather since the collapse of the pool roof. The unit is clearly many decades old, given the type of construction. Given that pool ventilation systems operate with warm humid air, which may also contain traces of the pool water sterilisation chemicals, they usually corrode far more quickly than “normal” ventilation systems. We would expect this to be the case in this installation.

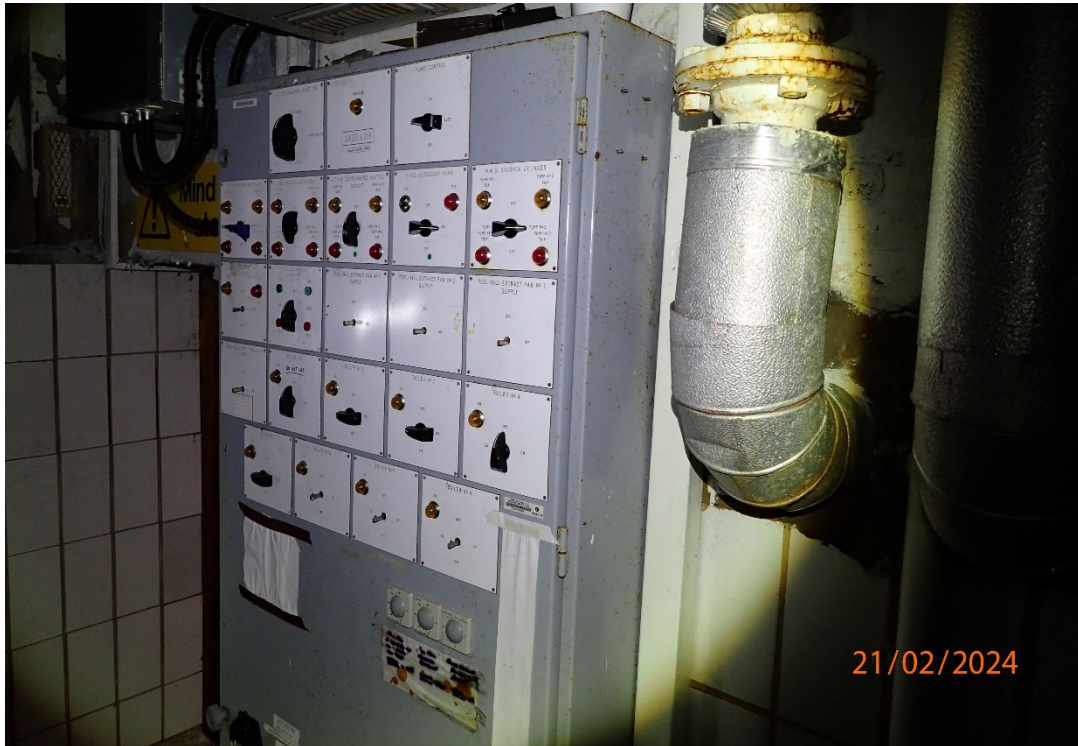
HVAC Control Panel

Significant corrosion is evident on the enclosure metal panels. Several of the switches have had the selector knobs removed.

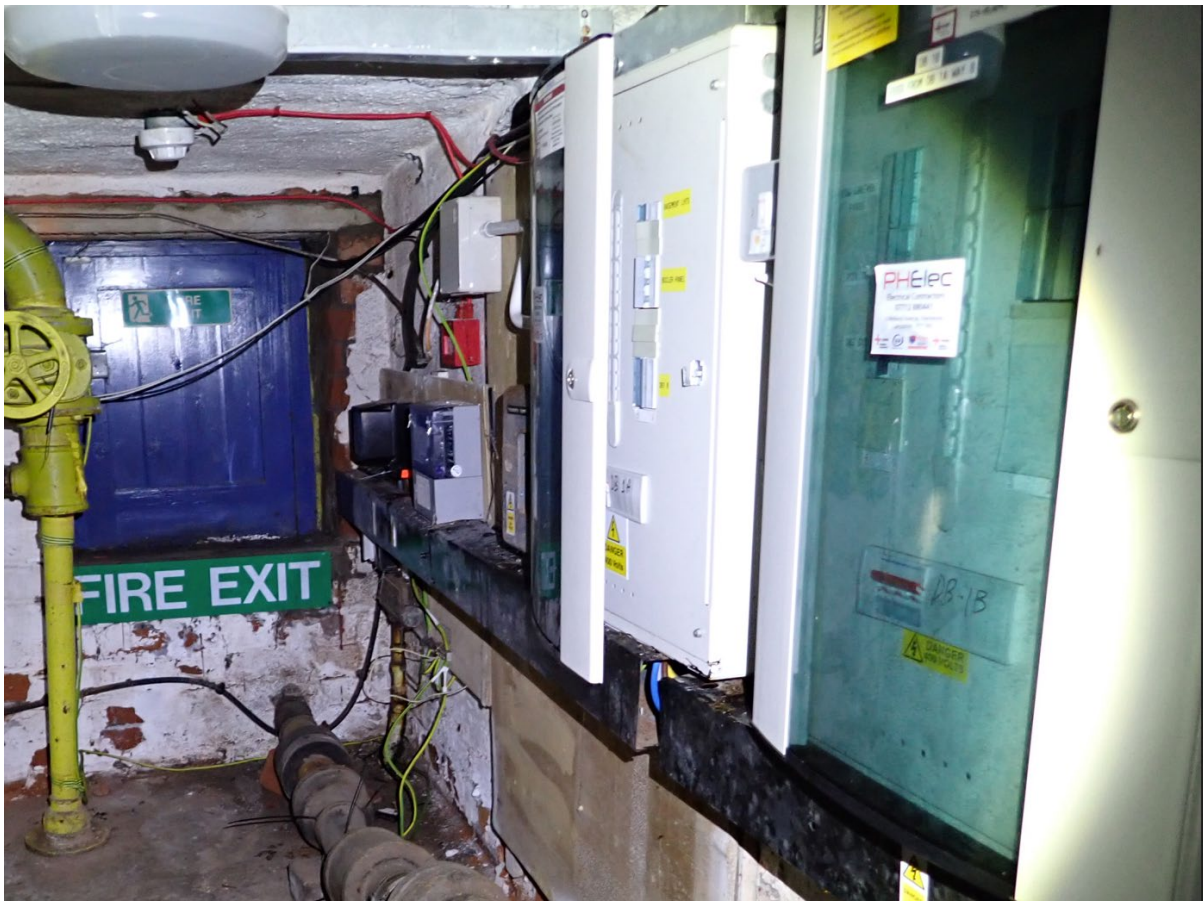
Main Distribution Boards – Basement

The containment, distribution boards & other switch gear specifically within the harsh environment of the basement are corroded. The IP ratings of the equipment and containment is compromised with direct access to single insulated exposed cables evident during the survey.

The existing Earthing & Bonding arrangement appears to be in poor condition with some main protective bonding showing signs of deterioration.

A recommendation for the proposed works would be to install a switch fuse in the tunnel with a submain to another dryer location with better access, or alternatively relocate the electrical incomer.

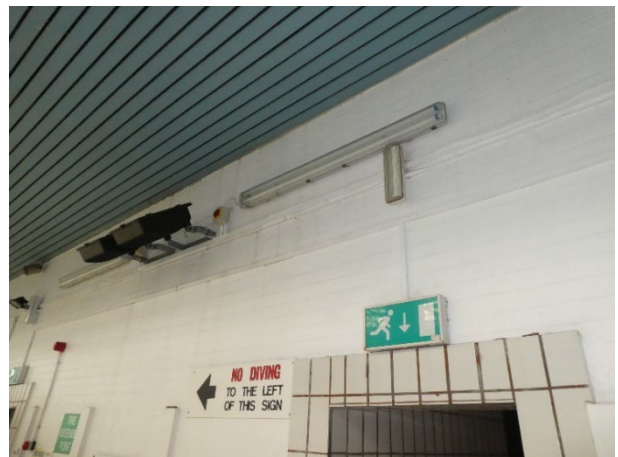
Swimming Pool Lighting

The Swimming Pool is served with Metal Halide Flood lights, these are not yet obsolete but appear to be circa 20 years old and are likely to be at the end of their economic life and are recommended for replacement with modern high efficiency LED lights.

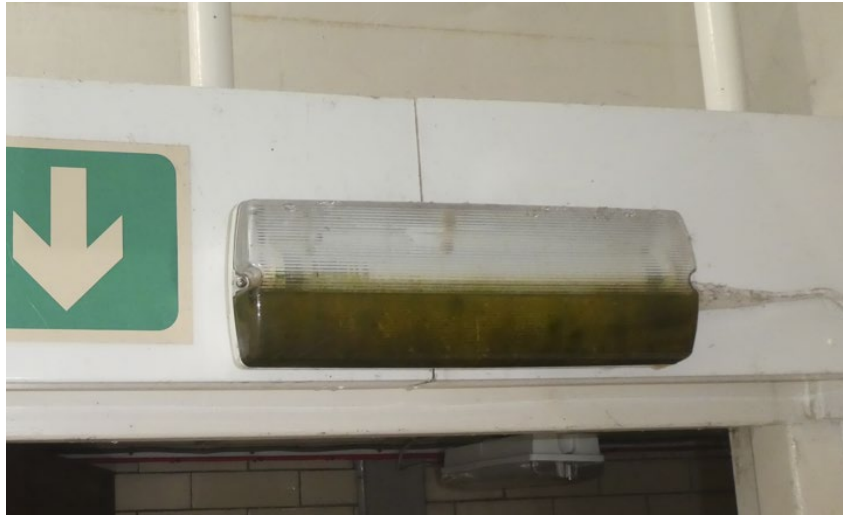
Typical Emergency Luminaire

The emergency lighting was observed to be self-contained luminaires with individual battery packs. The installation was not functional during the survey with evidence of water ingress in some fittings.

Following the full deep discharge of the batteries since the closure and isolation of lighting circuits, the luminaires will be beyond recovery and will require a full replacement.

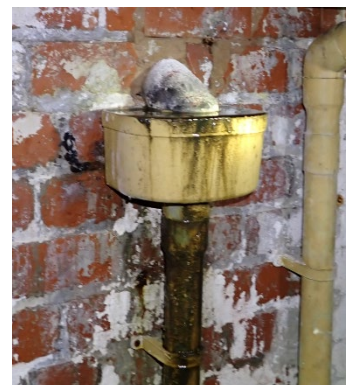
The existing skimmers are ornate gravity fed and deposit pool water into rainwater style hoppers before entering the filtration pipework, these are all currently full of standing water, full of biofilm and algae.

Existing Pool Skimmer

Existing Pool Skimmer Hoppers

This open drainage system is aiding the moist chlorine environment causing accelerated corrosion of services within the basement; therefore, it is recommended these skimmers are isolated / capped off somehow but retained for their ornate features, and a new sealed system installed.

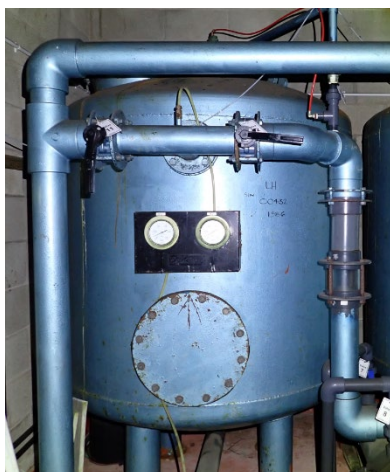
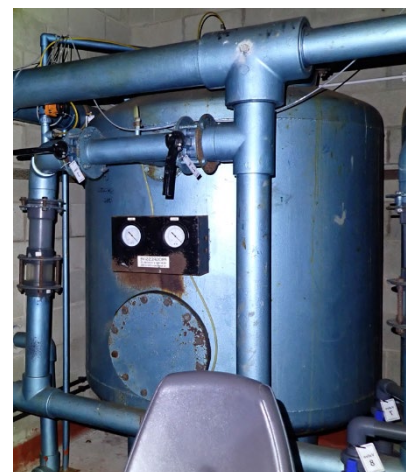
Main Pool Filtration Tank No1

Main Pool Filtration Tank No2

The filtration tanks should be relined at regular intervals and after 3 re-linings the units should be replaced. As such due to the age, it is recommended that a new filtration system is installed to reduce the risk of reliability issues and enhance the filtration capability ensuring water quality.

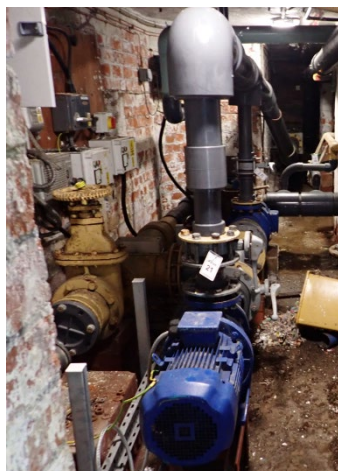
Basement Filtration Pumps

The existing pumps appear to be in reasonable condition, and one motor has apparently been re-wound prior to the pool closure. There is the possibility that these motors may be able to be re-used however at this stage as this is an unknown, new should be allowed for and investigated further at a later stage.

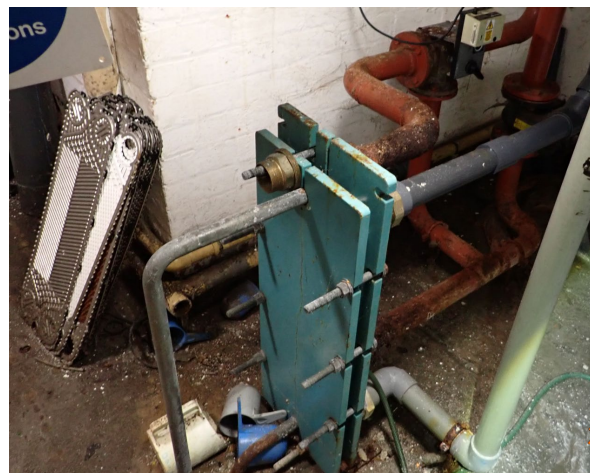
Pool Heat Exchanger

The pool is currently fed via the 5 existing boilers as detailed within the mechanical section above, this feeds a plate heat exchanger (HEX). All connecting pipe work to the HEX and including the HEX unit are badly corroded and covered in detritus. the unit is bolted directly to the cold floor. There is some evidence that there have been previous issues with this unit as there are spare contact plates adjacent to the unit.

We do not recommend the re-use of this unit as this style of unit will be inefficient, it will not have sufficient contact area for the reduced flow & return temperatures required to ensure condensing mode on the modern GAS heating solution for Option 1 and will be massively undersized for the other solution when fed via an ASHP where the flow & return temperatures are lower still.

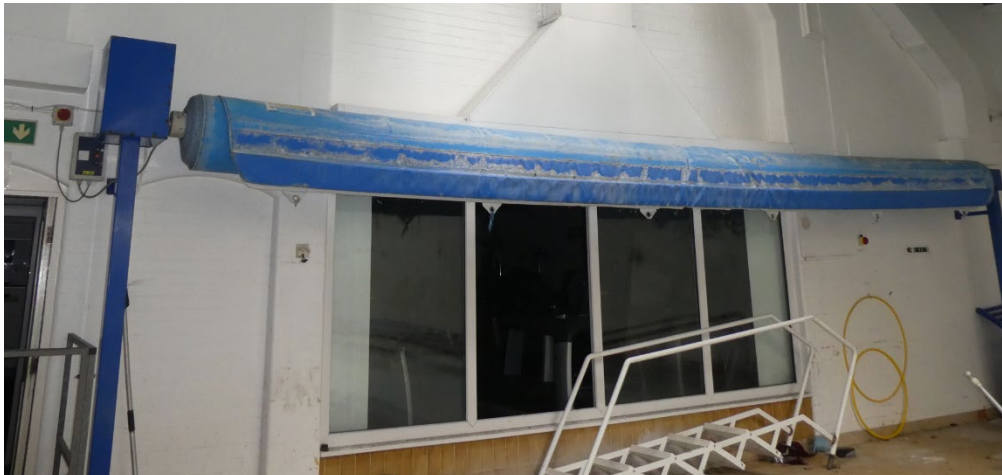
Pool Evaporation Cover

The existing pool cover is mounted in front of the gym on the pool side and is motorised and mounted on painted steel stanchions. The cover has been exposed to the elements since the roof damage and is showing signs of age through deterioration of the fabric, discoloration through chlorine bleaching and UV damage.

It is unknown at this stage the exact condition as it is fully closed and was non-operational. As such we would recommend that this unit is replaced with new.
