Scheme Title: Ashton gardens lighting Improvements and additions

The project involves improvements to the existing lighting to Ashton Gardens.

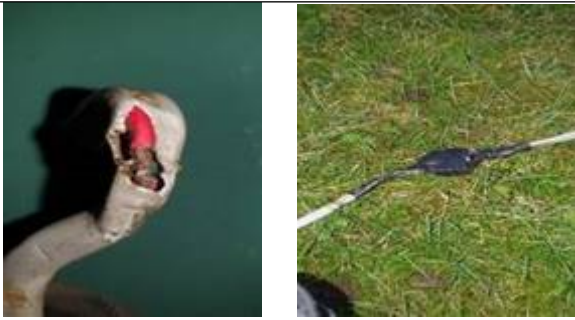
The lighting columns are all functioning but there is damage identified to the internal cabling, this is probably due to mechanical strain, metal fatigue or abrasion, these need to be replaced with suitable flexible cable, (not solid conductors, twin and earth)

There is also a problem with the hinged columns with cables becoming trapped and crushed in the hinged joint, because of the inappropriate cable installed.

Damage to cable inside the column including evidence of previous repairs

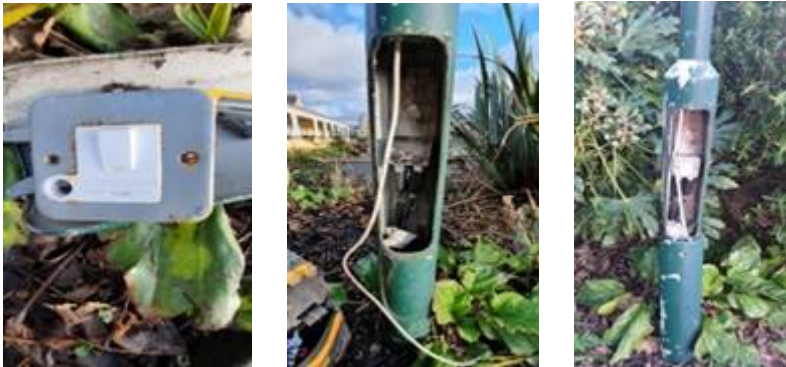
There are also problems with the fuse cutouts to each column, some have water, insect ingress and others have metal clad switch fuses that are not appropriate for the environment

Columns around the café have inappropriate metal clad switch fuses installed

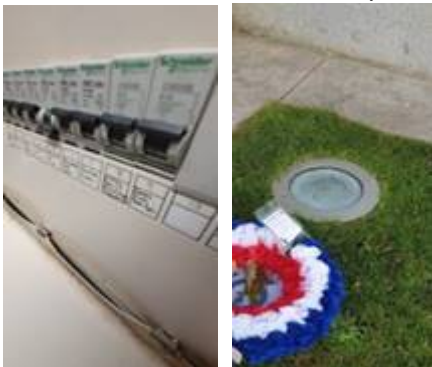
Most of the in-ground uplights have failed, the 7No. metal halide lamp versions have low insulation resistance (IR) they are supplied by final circuits with RCBO protection, and will typically operate for a few days before tripping out, this is due to water ingress, dampness to the wiring connections at the luminaries and internal component's,

Distribution equipment and water ingress to luminaries

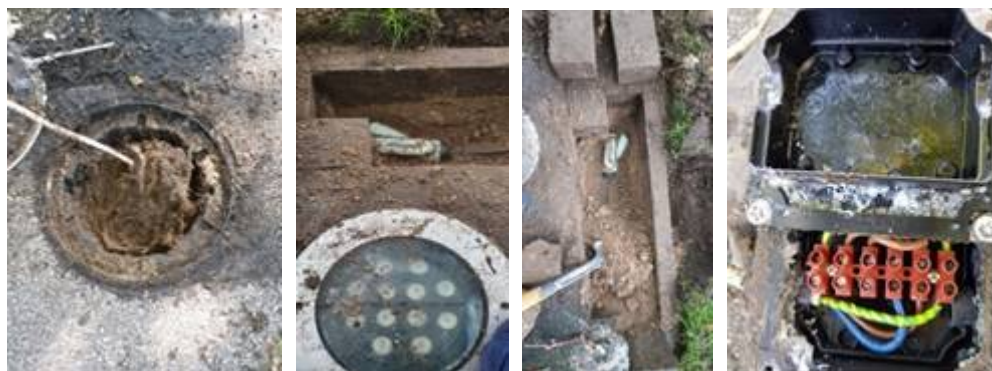
The 10No. LED in-ground uplighters to the main boulevard have also have low insulation resistance on the circuit, preventing them from being operated, this appears to be again from water ingress to the luminaries, these are sealed units, as all 10No. are on the same circuit with underground resin filled tee joints to each luminaire, it is not possible to readily identify if one or if all ten luminaries are responsible for the fault, it will require excavation and isolation of every unit.

It appears that the luminaries are located in areas that don't have good drainage and are underwater in puddles when it rains, sometimes for prolonged periods (the IP rating is not suitable for under water use)

The underground SWA cabling and resin filled joints to the luminaries do appear to be installed to a good standard & relatively recently (2011/12 restoration works)

LED inground up-lighting to the "boulevard" showing debris washed into the luminaire housing, excavation of SWA cable and joint, water ingress within the luminaire wiring.

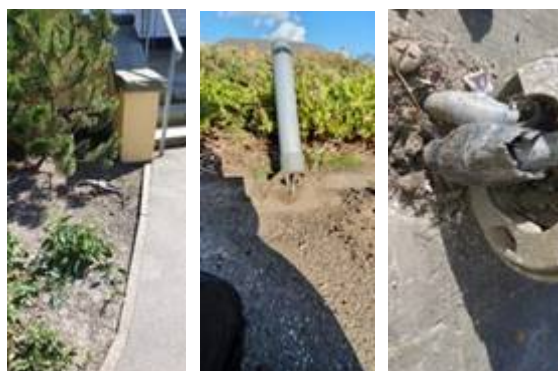
As with the inground lighting these are from the 2011 restoration works and supplied by underground SWA cables which appear to be in good order, however most of the bollards have suffered from vandalism, and those that have not been removed are currently working but all badly damaged.

The bollards are either missing or damaged

The existing lighting to the Gardens, will require replacement of the water damaged and vandalized luminaries, the distribution cables, circuit protection and lighting controls appear to be in good order and operational.
