# Arboricultural Condition Report - TPO 2016/05 Moss Side Lane

Job No: 60493277

Reference: Arboricultural Report

- 1.1.1 AECOM has been commissioned to carry out a tree condition survey in relation to the trees covered by Fylde Council Tree Preservation Order (TPO) 2016.05 Moss Side Lane, Wrea Green, Fylde.
- 1.1.2 The scope of work includes a tree survey to assess current condition and to highlight any potential hazards. The line of trees which have been assessed all have a stem diameter over 150mm at 1.5m and are located on Moss Side Lane.
- 1.1.3 The survey and the accompanying notes provide guidance as to the nature and condition of the existing tree stock in the survey area.

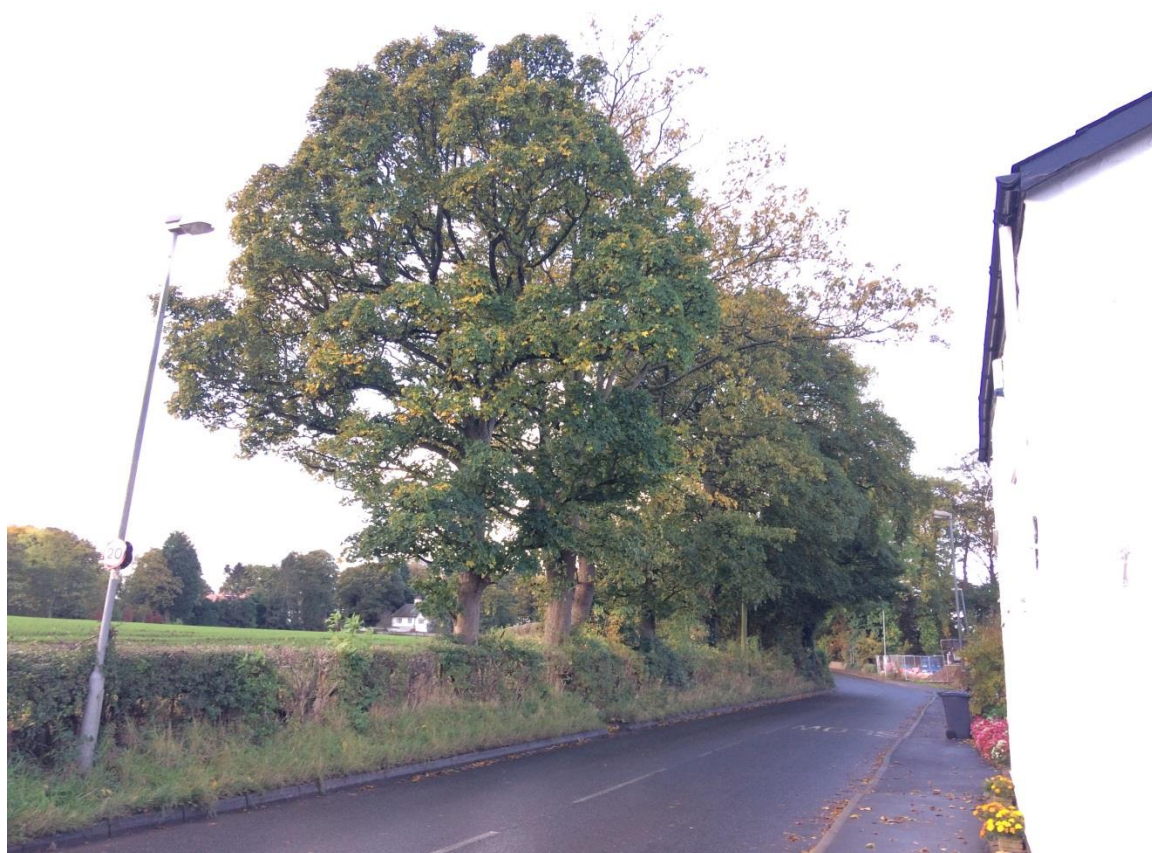
Photo 1 – Looking south west along Moss Side Lane with T1 in the foreground.

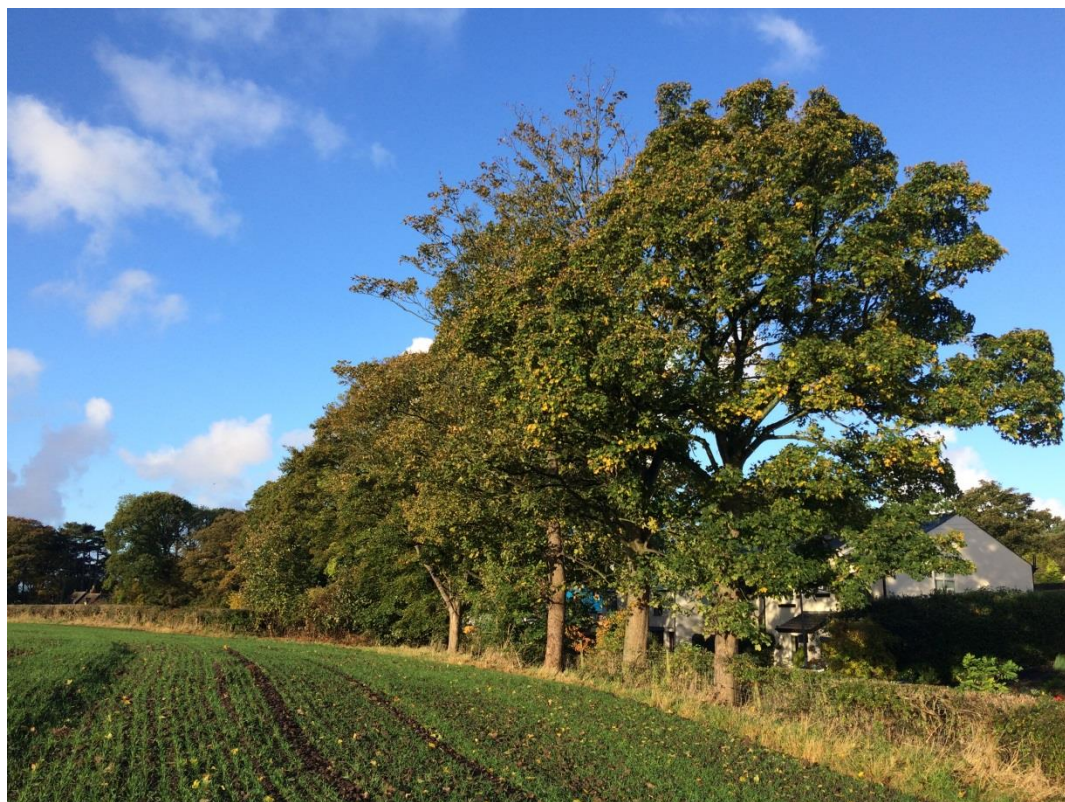
Photo 2 – Looking north west from within agricultural field with T1 in the foreground.

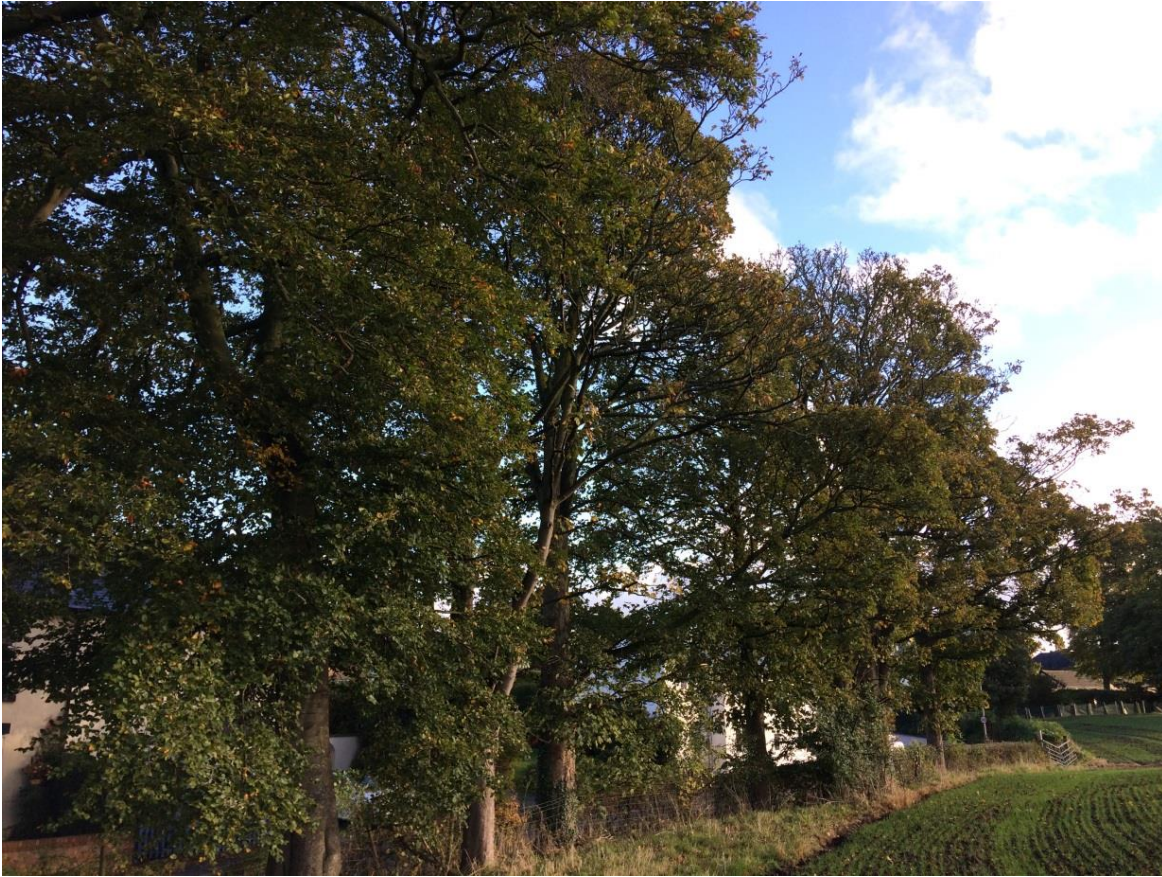
Photo 3 – Looking north east from within agricultural field to the south of the trees.

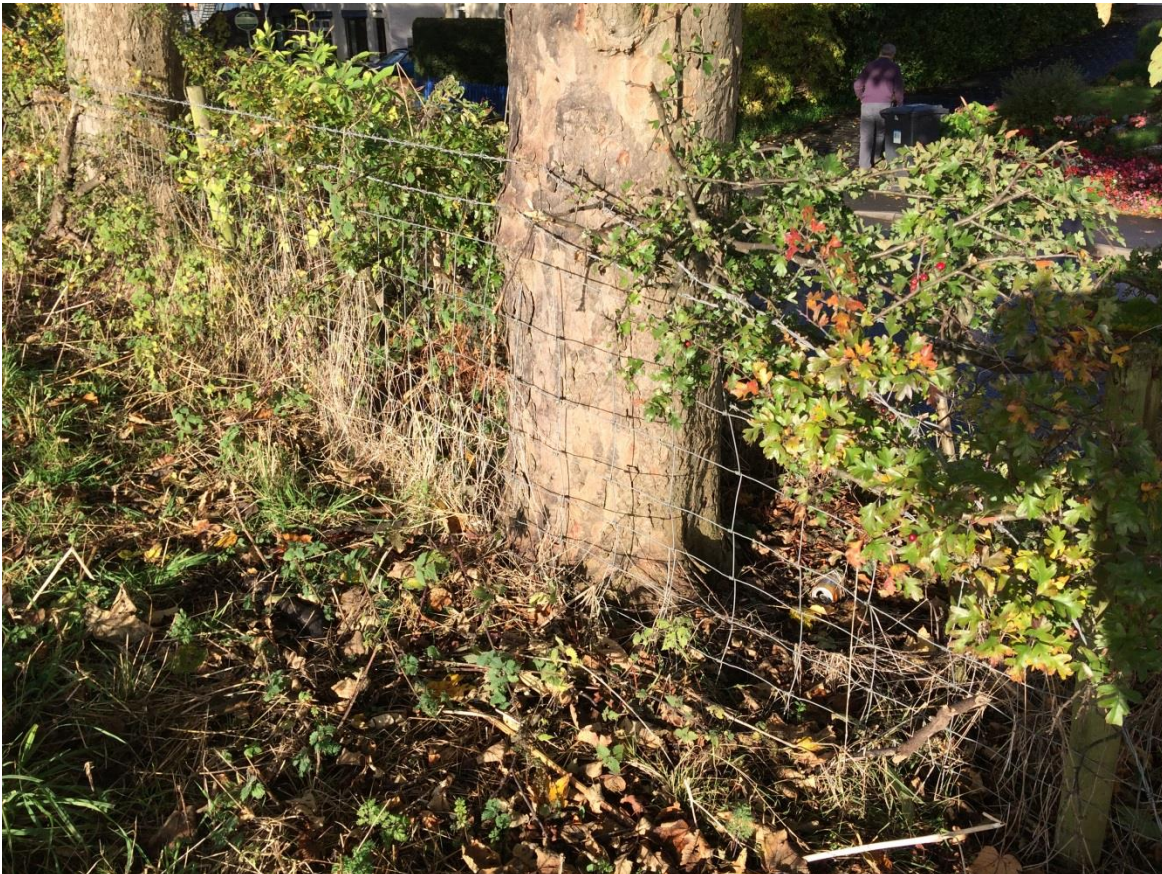
- 3.2.2 **T1** – A semi-mature sycamore (*A. pseudoplatanus*) in good to fair condition. The canopy is weighted predominantly to the east due to neighbouring tree to the west. The tree has suffered damage on its lower southern canopy, presumably due to farm machinery working the agricultural field. A wire fence is located adjacent to the southern side of the main stem and has resulted in the tree growing around and encapsulating the wire over time (see photo 3). Moderate deadwood was visible within the canopy, and tar spot (*Rhytisma acerinum*) is evident throughout the canopy. Although this is not generally viewed as being detrimental to the health of the tree it can be considered to have an effect on the amenity value of the tree.

Photo 4 – T1 growing around adjacent wire fence.

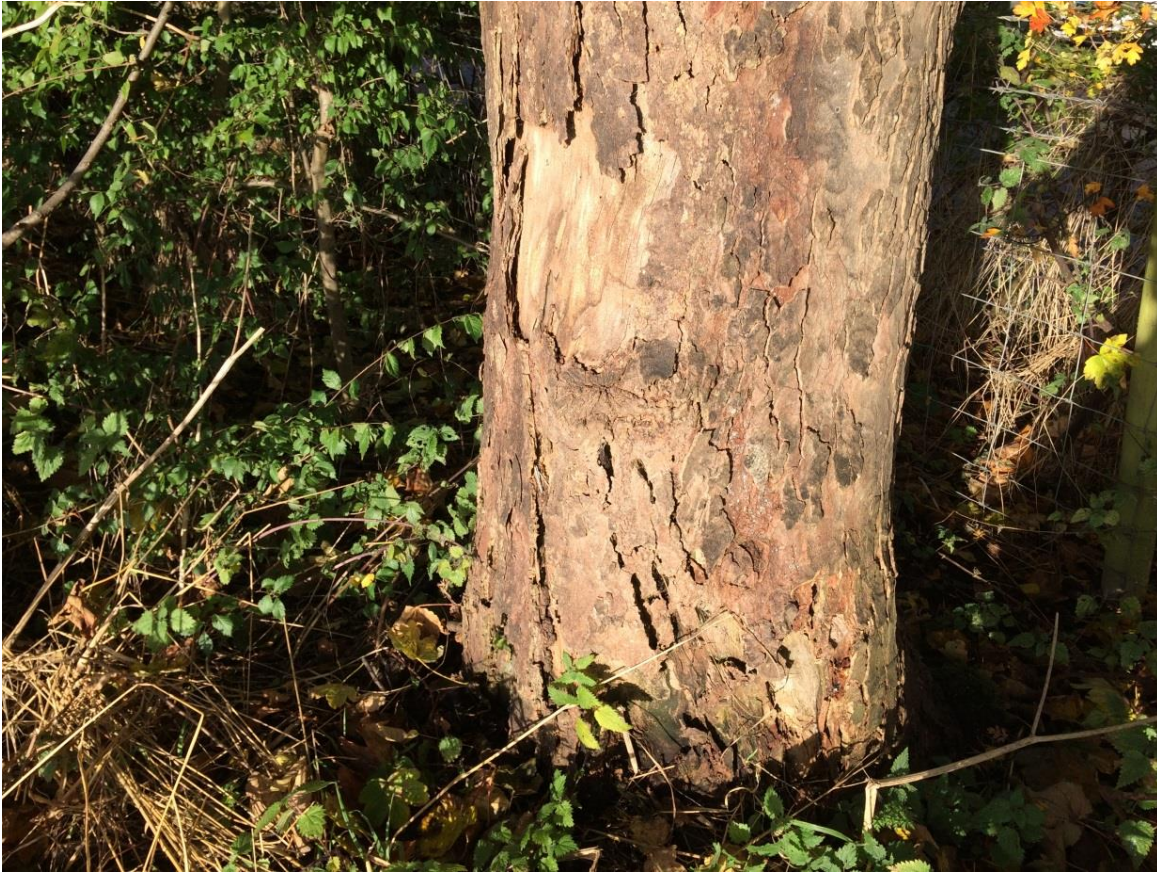
- 3.2.6 **T3** – A semi-mature sycamore (*A. pseudoplatanus*) in good to fair condition. The canopy of this tree has grown as part of a collective with the rest of this grouping. Moderate deadwood was noted along with broken branches on the southern lower canopy. The tree has a sparse crown with small leaves, minor die-back, and areas of dead bark and delamination at the base of the tree (see photo 5) indicate an impaired physiological system. Tar spot (*R. acerinum*) was also evident throughout the canopy. Long term retention is questionable given the apparent poor health of the tree. This has been classified as a 'C' category tree based on its low landscape quality.

Photo 5 – dead bark at base of T3

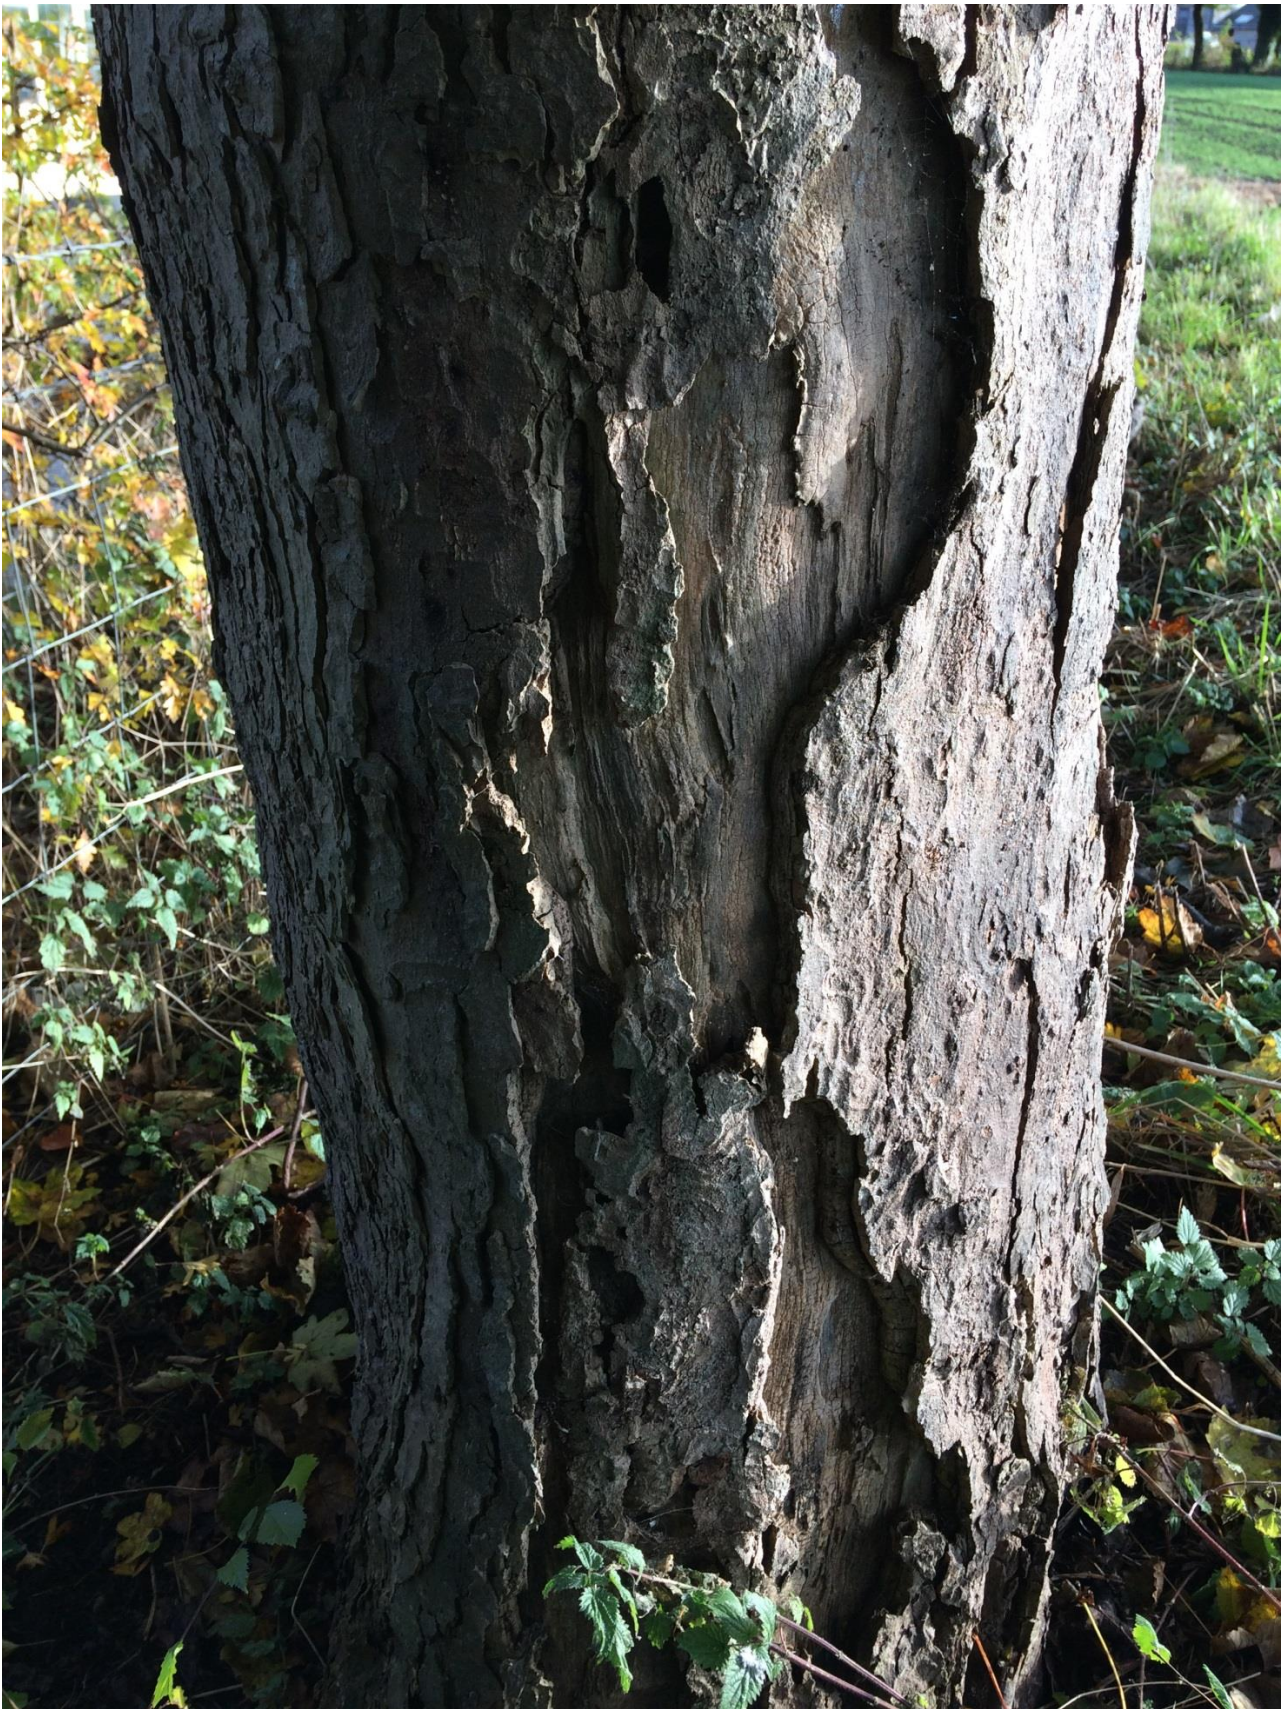
Photo 6 – Dead bark and delamination at the base of T3.

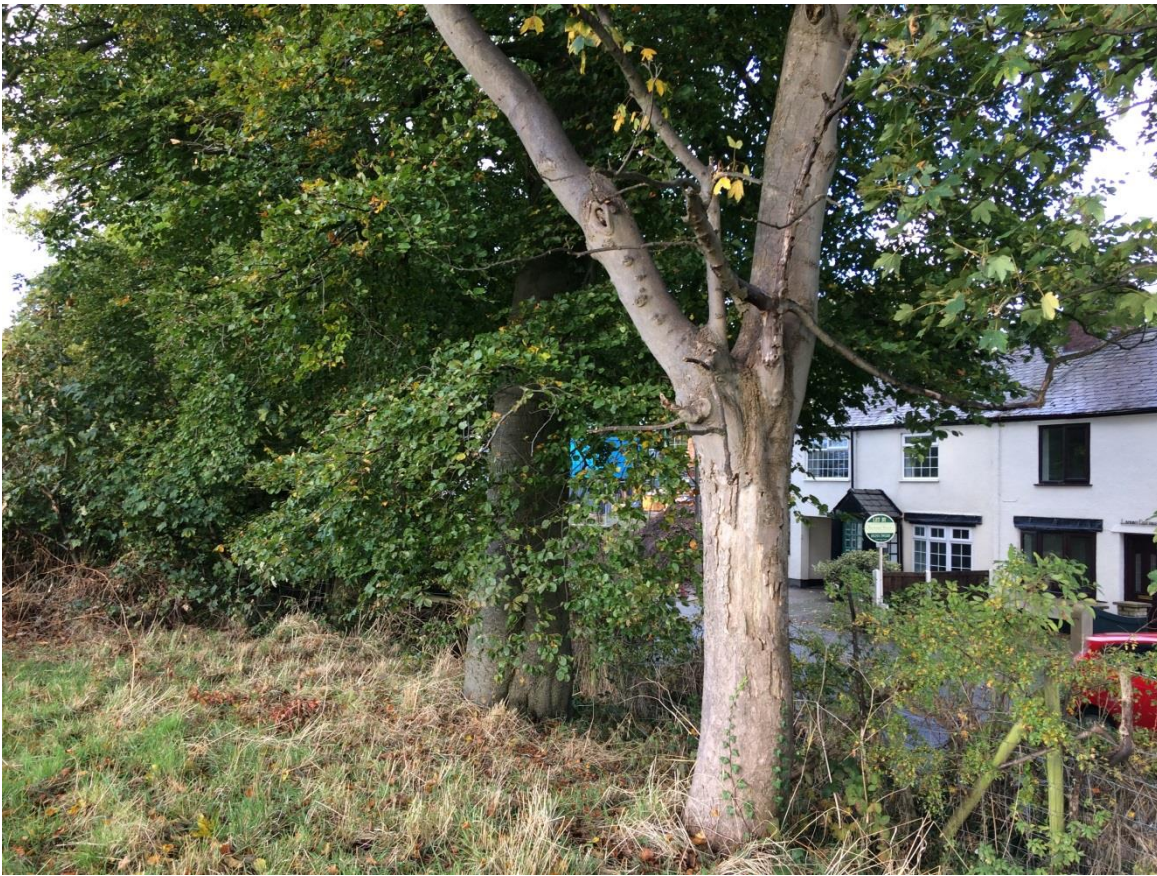
- 3.2.9 **T6** – A semi-mature sycamore (*A. pseudoplatanus*) in poor condition and is in a state of severe decline. The tree has delaminating bark on the main stem with excessive die-back, early defoliation and moderate deadwood. It is assumed that this tree has not been included in the group TPO given its current condition. Removal within 6 months has been recommended. This has been classified as a 'U' category tree.

Photo 7 – T6 in later stages of die-back and decline, rated 'U' category.

T6	Sycamore	<i>Acer pseudoplatanus</i>	15	450	2.0	2.5	7.0	4.0	3.0	P	P	2.5	S	Sm	Tree is in advanced stages of decline. Delaminating bark on main stem and excessive die-back and early defoliation. Moderate deadwood.	Fell within 6 months	<10	U	5.4	92
T7	Beech	<i>Fagus sylvatica</i>	17	710	5.0	3.0	4.5	3.0	0.0	G-F	G-F	5.0	E	Sm-Em	Bulge at base of main stem on east side with some exudation present both at the base of the tree and other secondary limbs. Possible symptoms of beech bark disease identified. Moderate to major deadwood in canopy over highway. Minor die-back in the canopy. Slight lean to the north towards the highway.	Remove deadwood over highway within 3 months.	40+	C2	8.5	228
T8	Beech	<i>Fagus sylvatica</i>	17	644	2.5	4.0	6.5	4.0	1.5	F	F-P	5.0	E	Sm-Em	Single stem tree with moderate deadwood and minor die-back. Slight bulge at base of tree. Signs of weak point/graft union at base of tree. Wire fence in-grown into main stem. Cavity on main stem at 6.5m on west side from historic failure. Branches on northern canopy making contact with adjacent phone lines.	Aerial inspection is required to assess wound at 6.5m for any decay issues. Graft union will require regular monitoring to assess for any structural issues. Both to be done within 12 months.	20+	C2	7.7	188

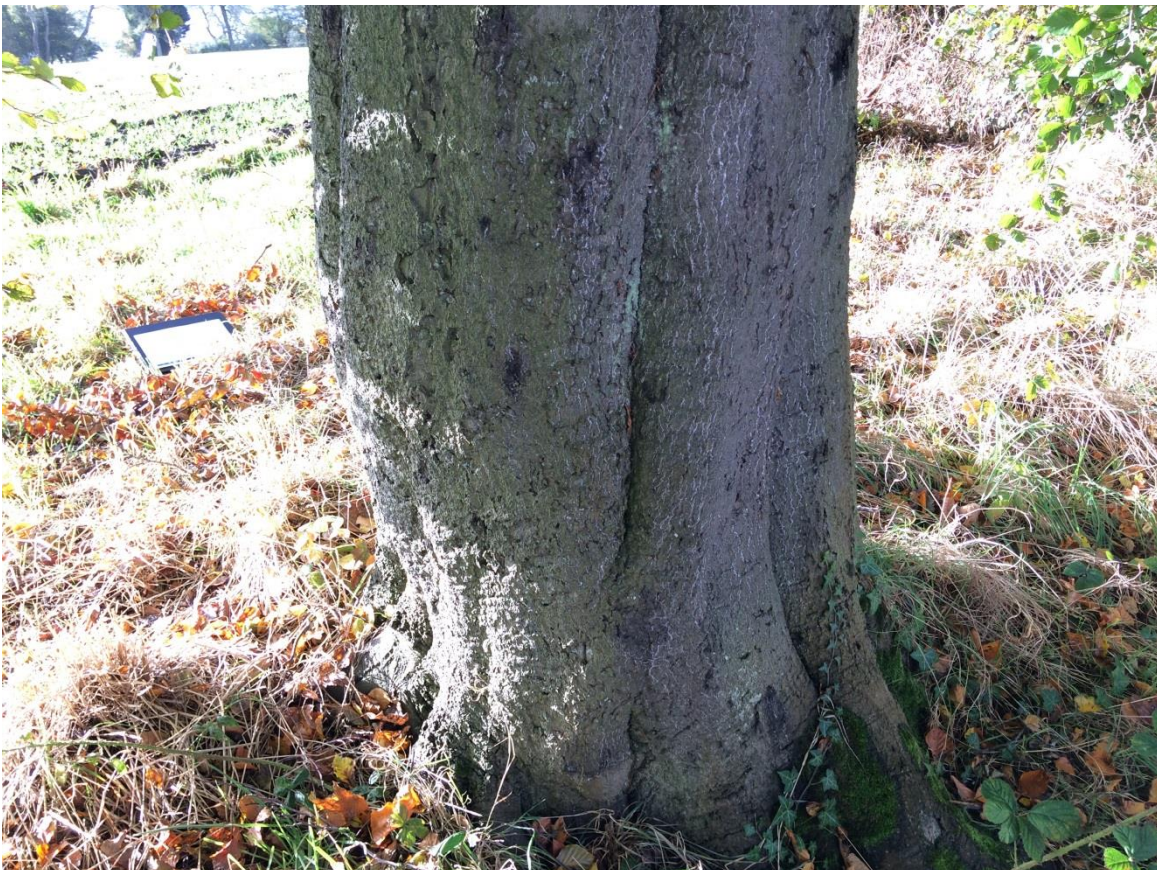
- 3.2.12 Areas of exudation and secretions of white waxy substance (see photos 8 and 10) were also found around the base of the tree. These symptoms indicate the presence of beech bark disease. This is not considered a significant hazard although it can lead to further colonization by airborne pathogens into the exposed sapwood. This tree has been classified as a 'C' category tree based on its low landscape quality.

Photo 8 – T7 with areas of exudation and bulging at base of main stem.

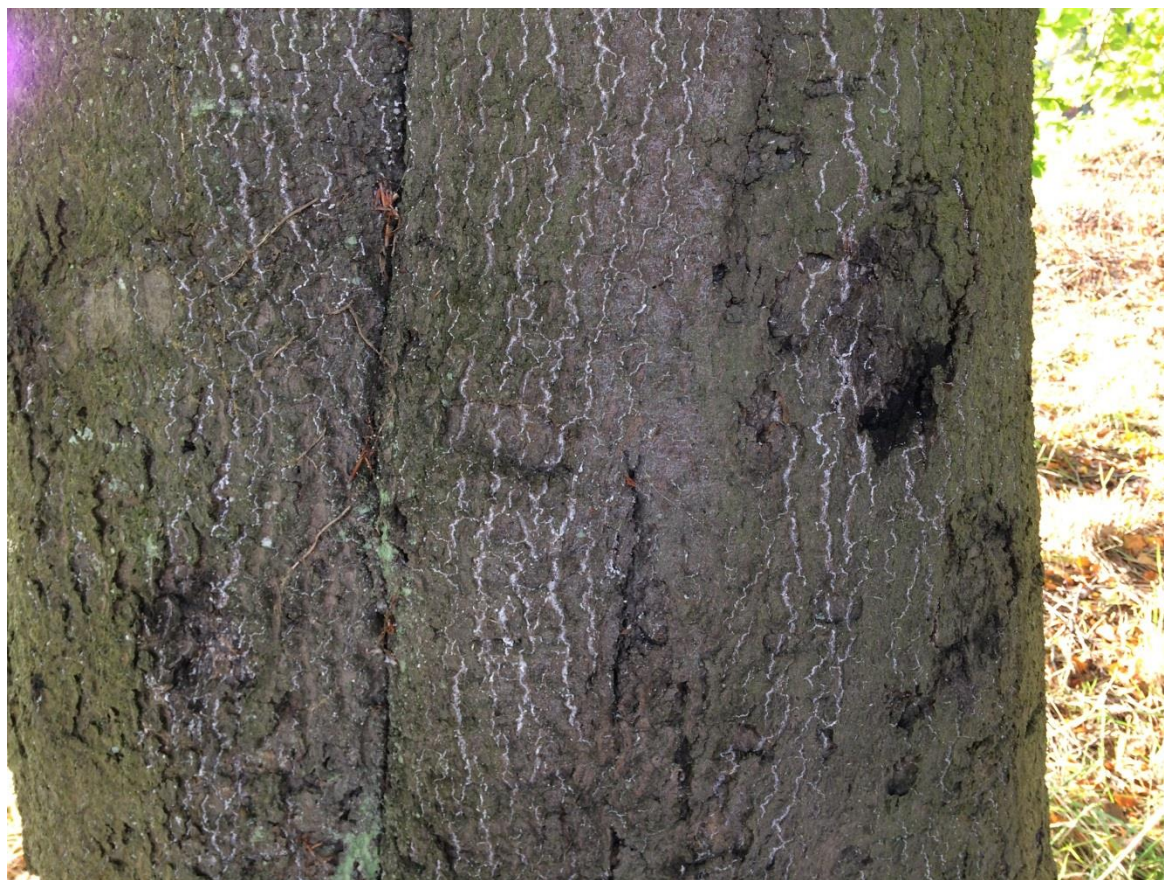
Photo 9 – Close up of symptoms of beech bark disease on T7.

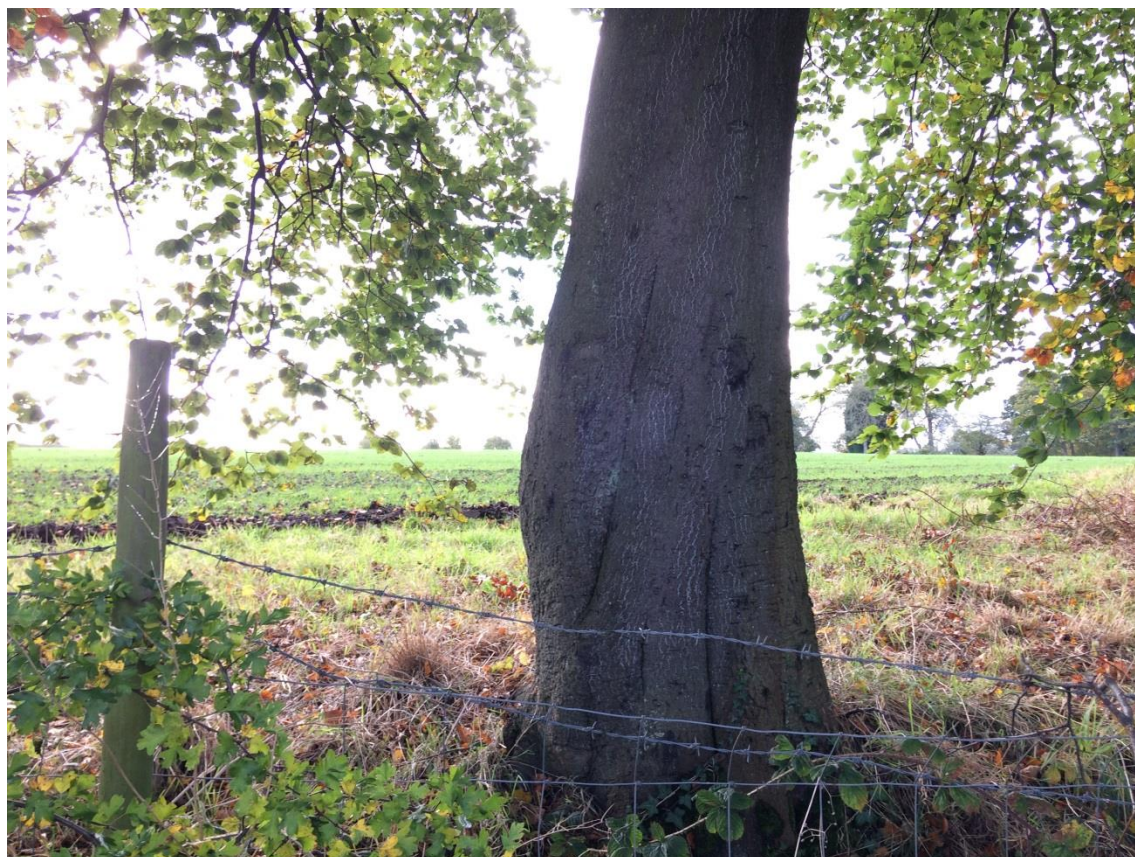
- 3.2.11 A bulge on the eastern section of the main stem was identified (see photo 10). This is feature is often associated with internal decay and represents the tree reacting with increased growth around an area potentially weakened by fungal infection (white rot). **Given the close proximity of the tree to the highway and private residences, a more detailed inspection of this area of the main stem is recommended.** A slight lean towards these targets also highlights the need for a more thorough inspection.

Photo 10 – Bulging at base of T7, looking south.

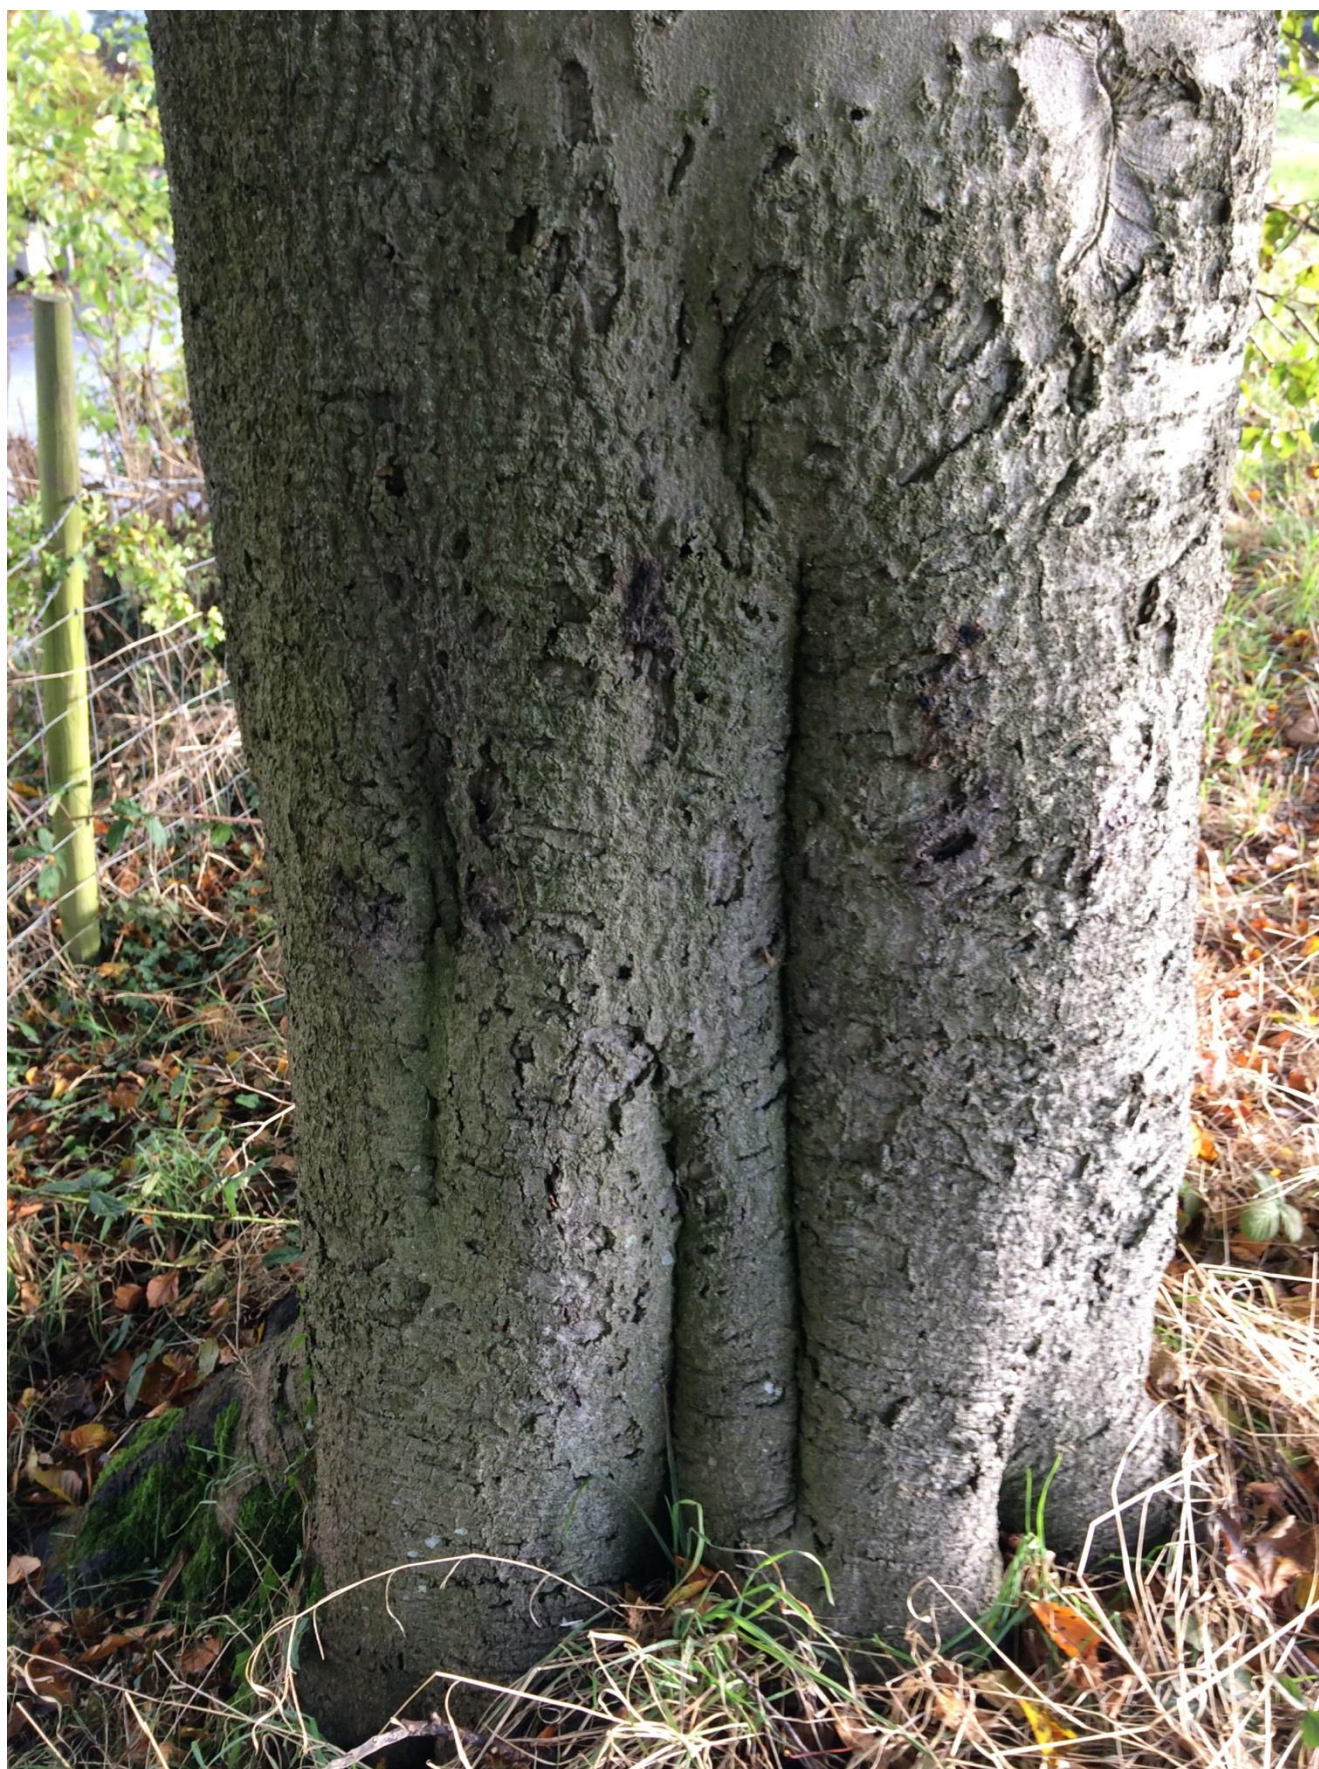
Photo 11 – Base of T7 on western side of main stem showing symptoms of beech bark disease.

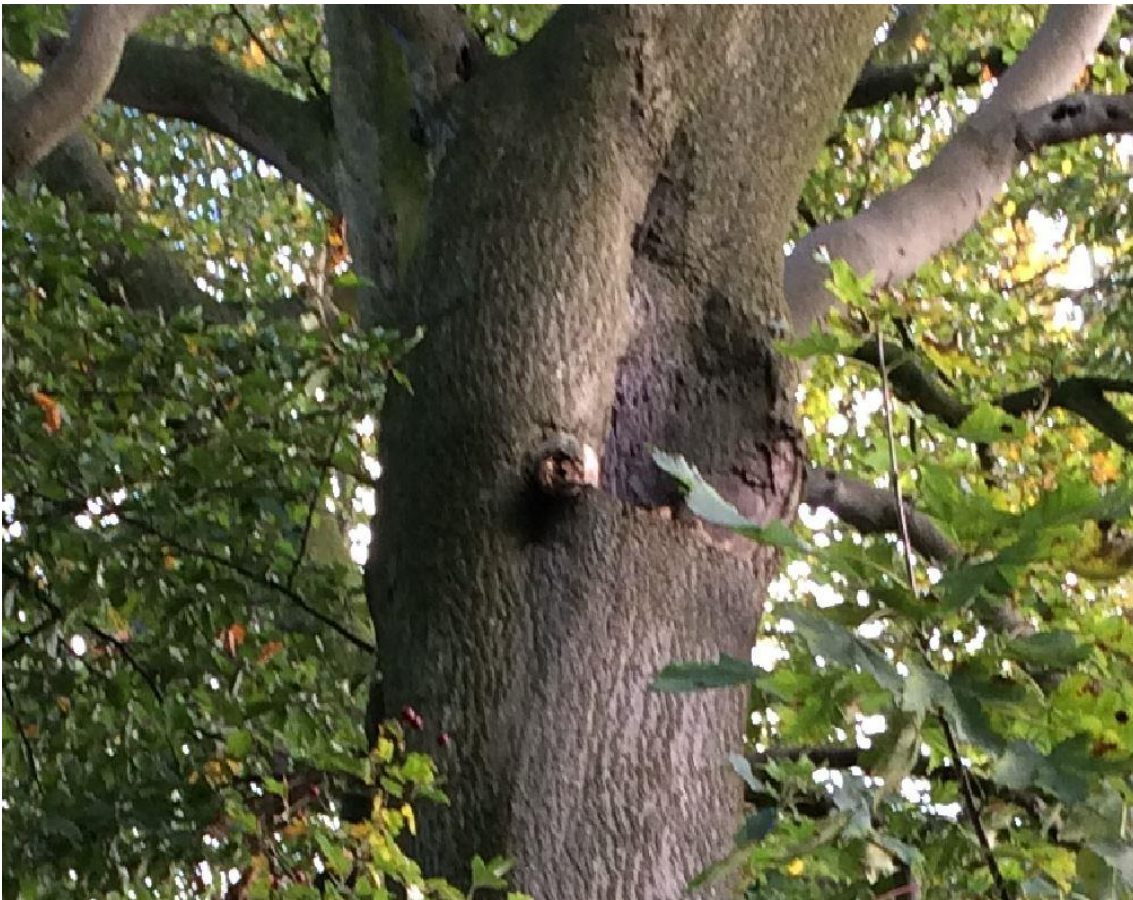
Photo 12 – Area of potential decay on main stem of T7 requiring further inspection.

- 6.1.2 Trees T7 and T8 require further in depth investigation to assess their long term safe retention due to the features identified and the high target represented by the public highway (B5259) and private residential properties located to the north of the group.

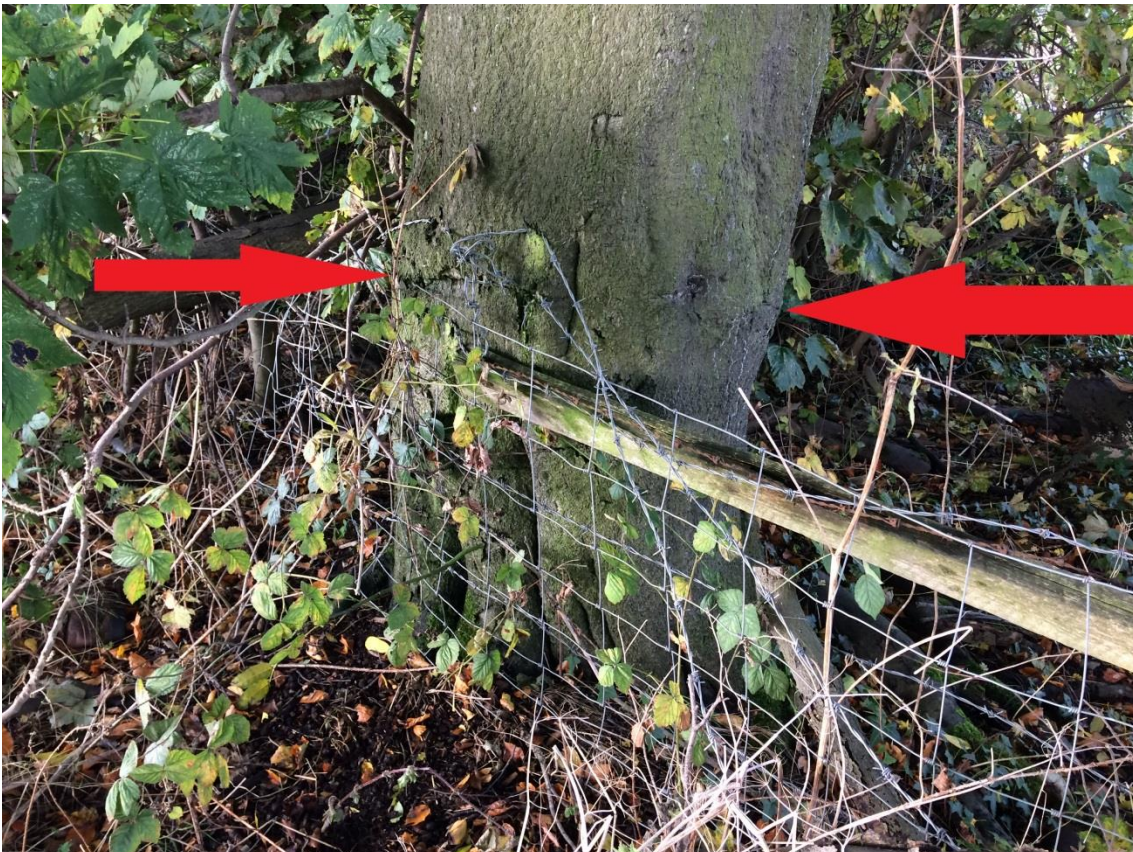
- 3.2.13 **T8** – A semi to early mature beech (*F. sylvatica*) in fair to poor condition. This is a single stem tree with moderate deadwood and minor die-back and a potential cavity on the on the west side of the main stem at approximately 6.5m above ground level. An aerial inspection would be required to fully assess the structural integrity around this area. A slight bulging was noted at approximately 0.5m on the main stem. Features suggesting a graft line were identified in the same area (see photos 13 to 15). This is considered a structural weak point and should be monitored for signs of potential failure. This tree has been classified as a 'C' category tree based on its low landscape quality.

Photo 13 – Base of T8 with areas highlighting potential structural issue on eastern side of stem.

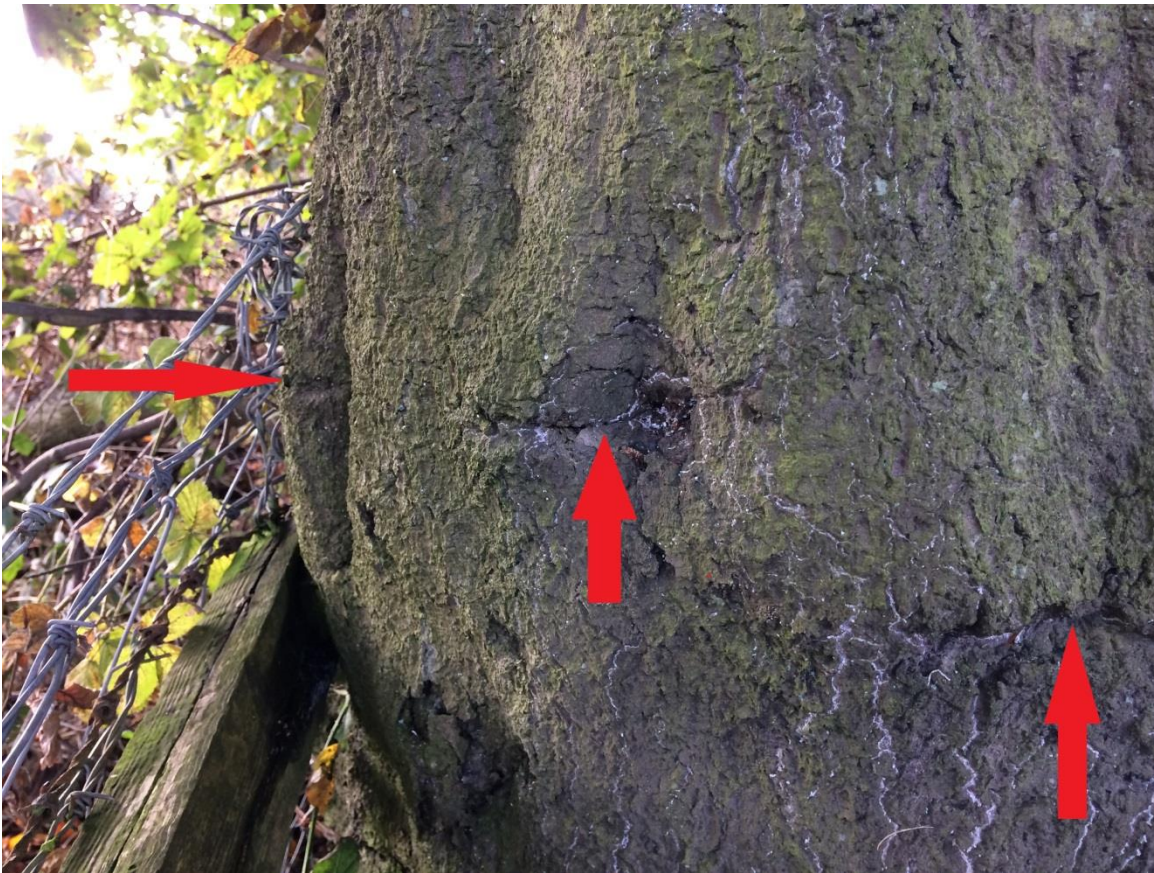
Photo 14 – Close up of northern section of stem, areas of potential structural weakness highlighted.

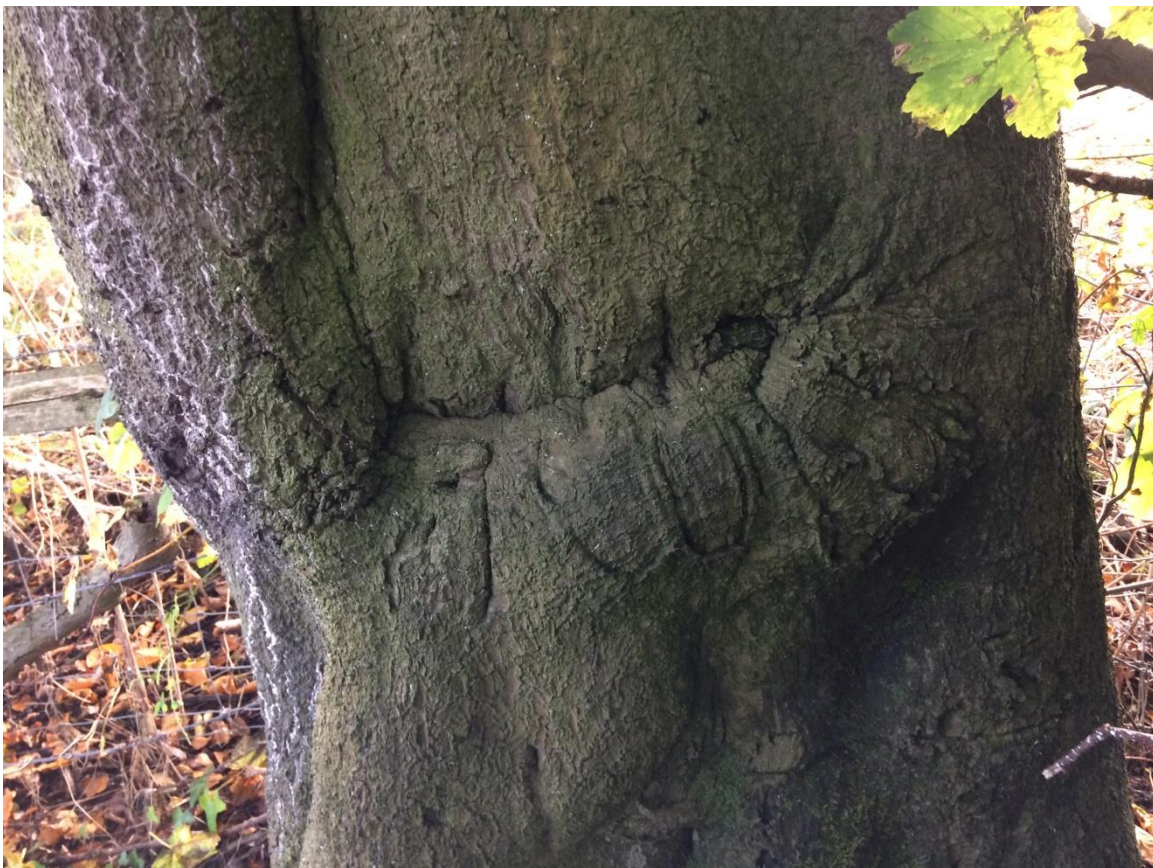
Photo 15 – Western side of T8 showing further potential structural weakness.

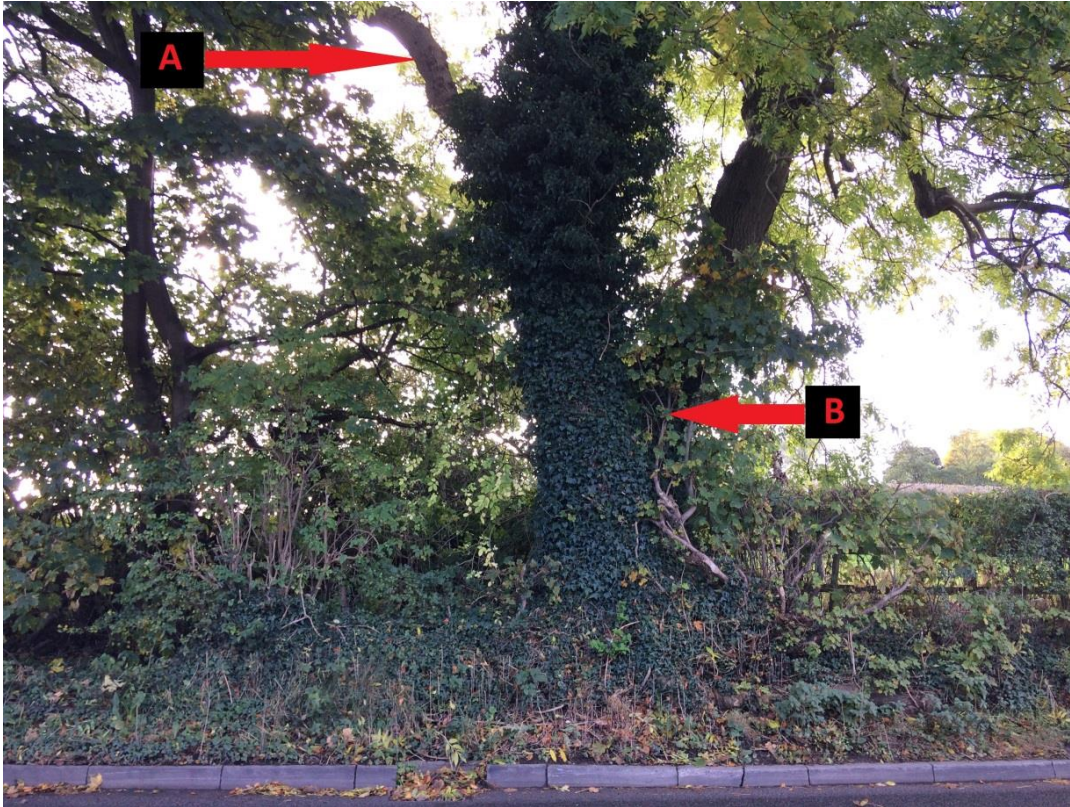
- 3.2.14 **T9** – An early-mature to mature ash (*F. excelsior*) tree in fair condition. There is dense ivy (*Hedera* sp.) extending from the base into the canopy; a full survey has therefore not been carried out. Co-dominant stems occur at 1m above ground level, with the union obscured by ivy (see photo 16 – feature B). There is also epicormic growth throughout the canopy, along with minor die-back. A secondary limb extending south has failed in the past. The remaining limb is approximately 5m in length and is now dying back (see photo 16 – feature A). *Daldinea concentrica* fungal fruiting bodies were present on this limb indicating areas of deadwood. The tree has limited rooting environment to the northern side due to its position directly adjacent to the highway (see photo 17). This tree will require the removal of ivy before a more thorough survey can be carried to fully assess its condition. This tree has been classified as a 'C' category tree based on its low landscape quality.

Photo 16 – T9 'A' is showing torn out limb extending south for approximately 5m, 'B' is showing ivy covered main union looking south from B5259.

- 6.1.3 It has not been possible to undertake a full inspection of T9 due to the dense ivy covering its stem; this will be required to confirm its potential long term viability. The tree is situated very close to the highway and could represent a significant hazard should any issues be identified.

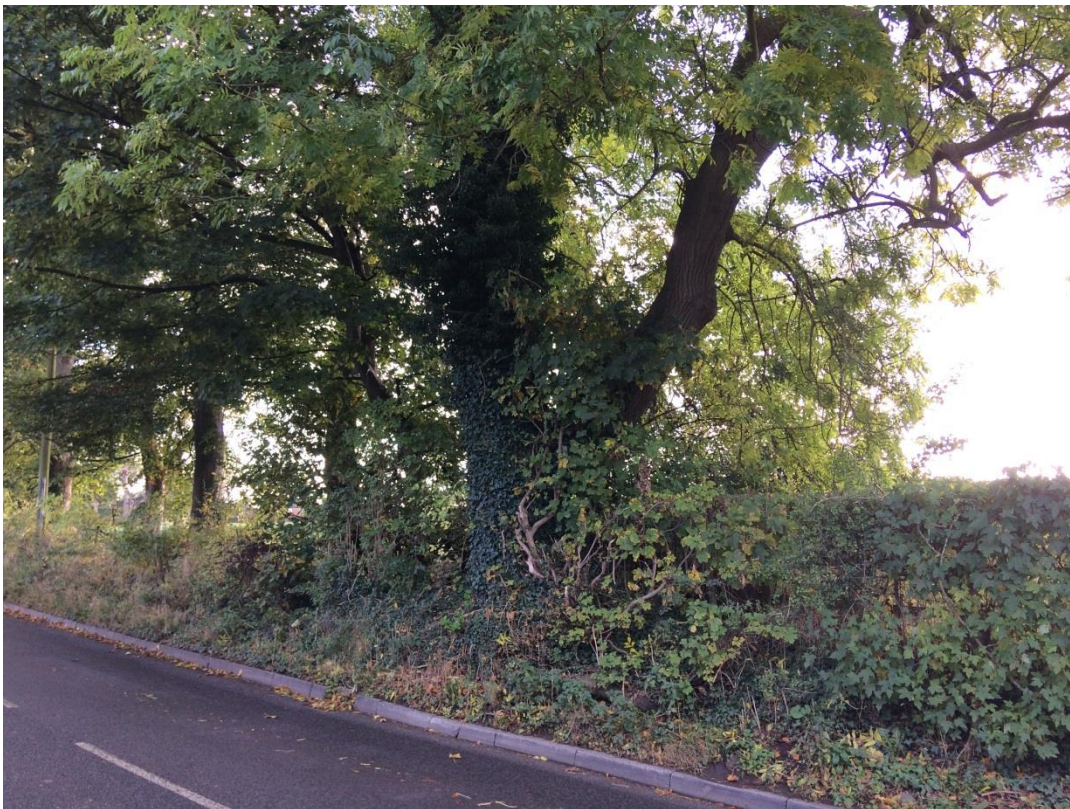
Photo 17 – Base of T9 close to highway

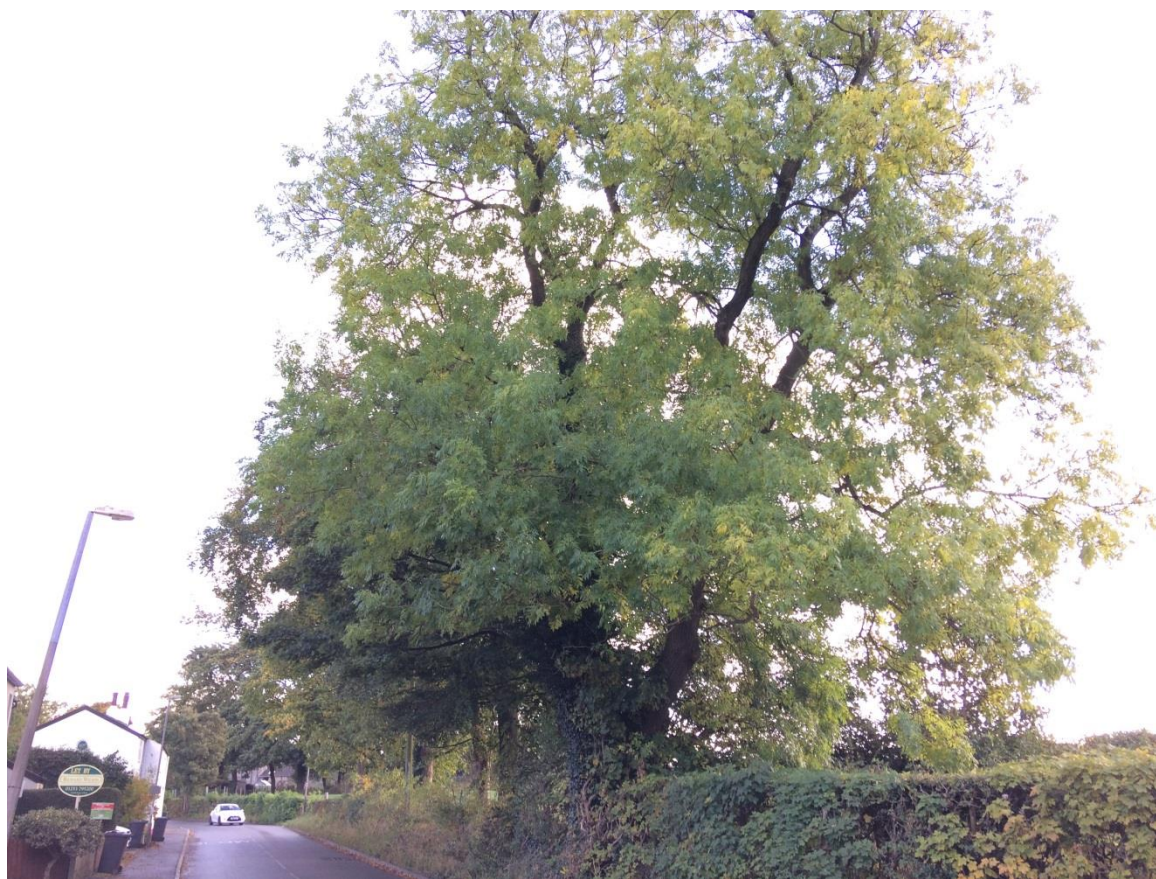
Photo 18 – T9 looking east.
