STAINING_VILLAGE
SW_REMEDIAL_WORKS

GENERAL_ARRANGEMENT
EXISTING_ISSUES_SHEET_2_OF_2

Drawing Number:
TS18015-002

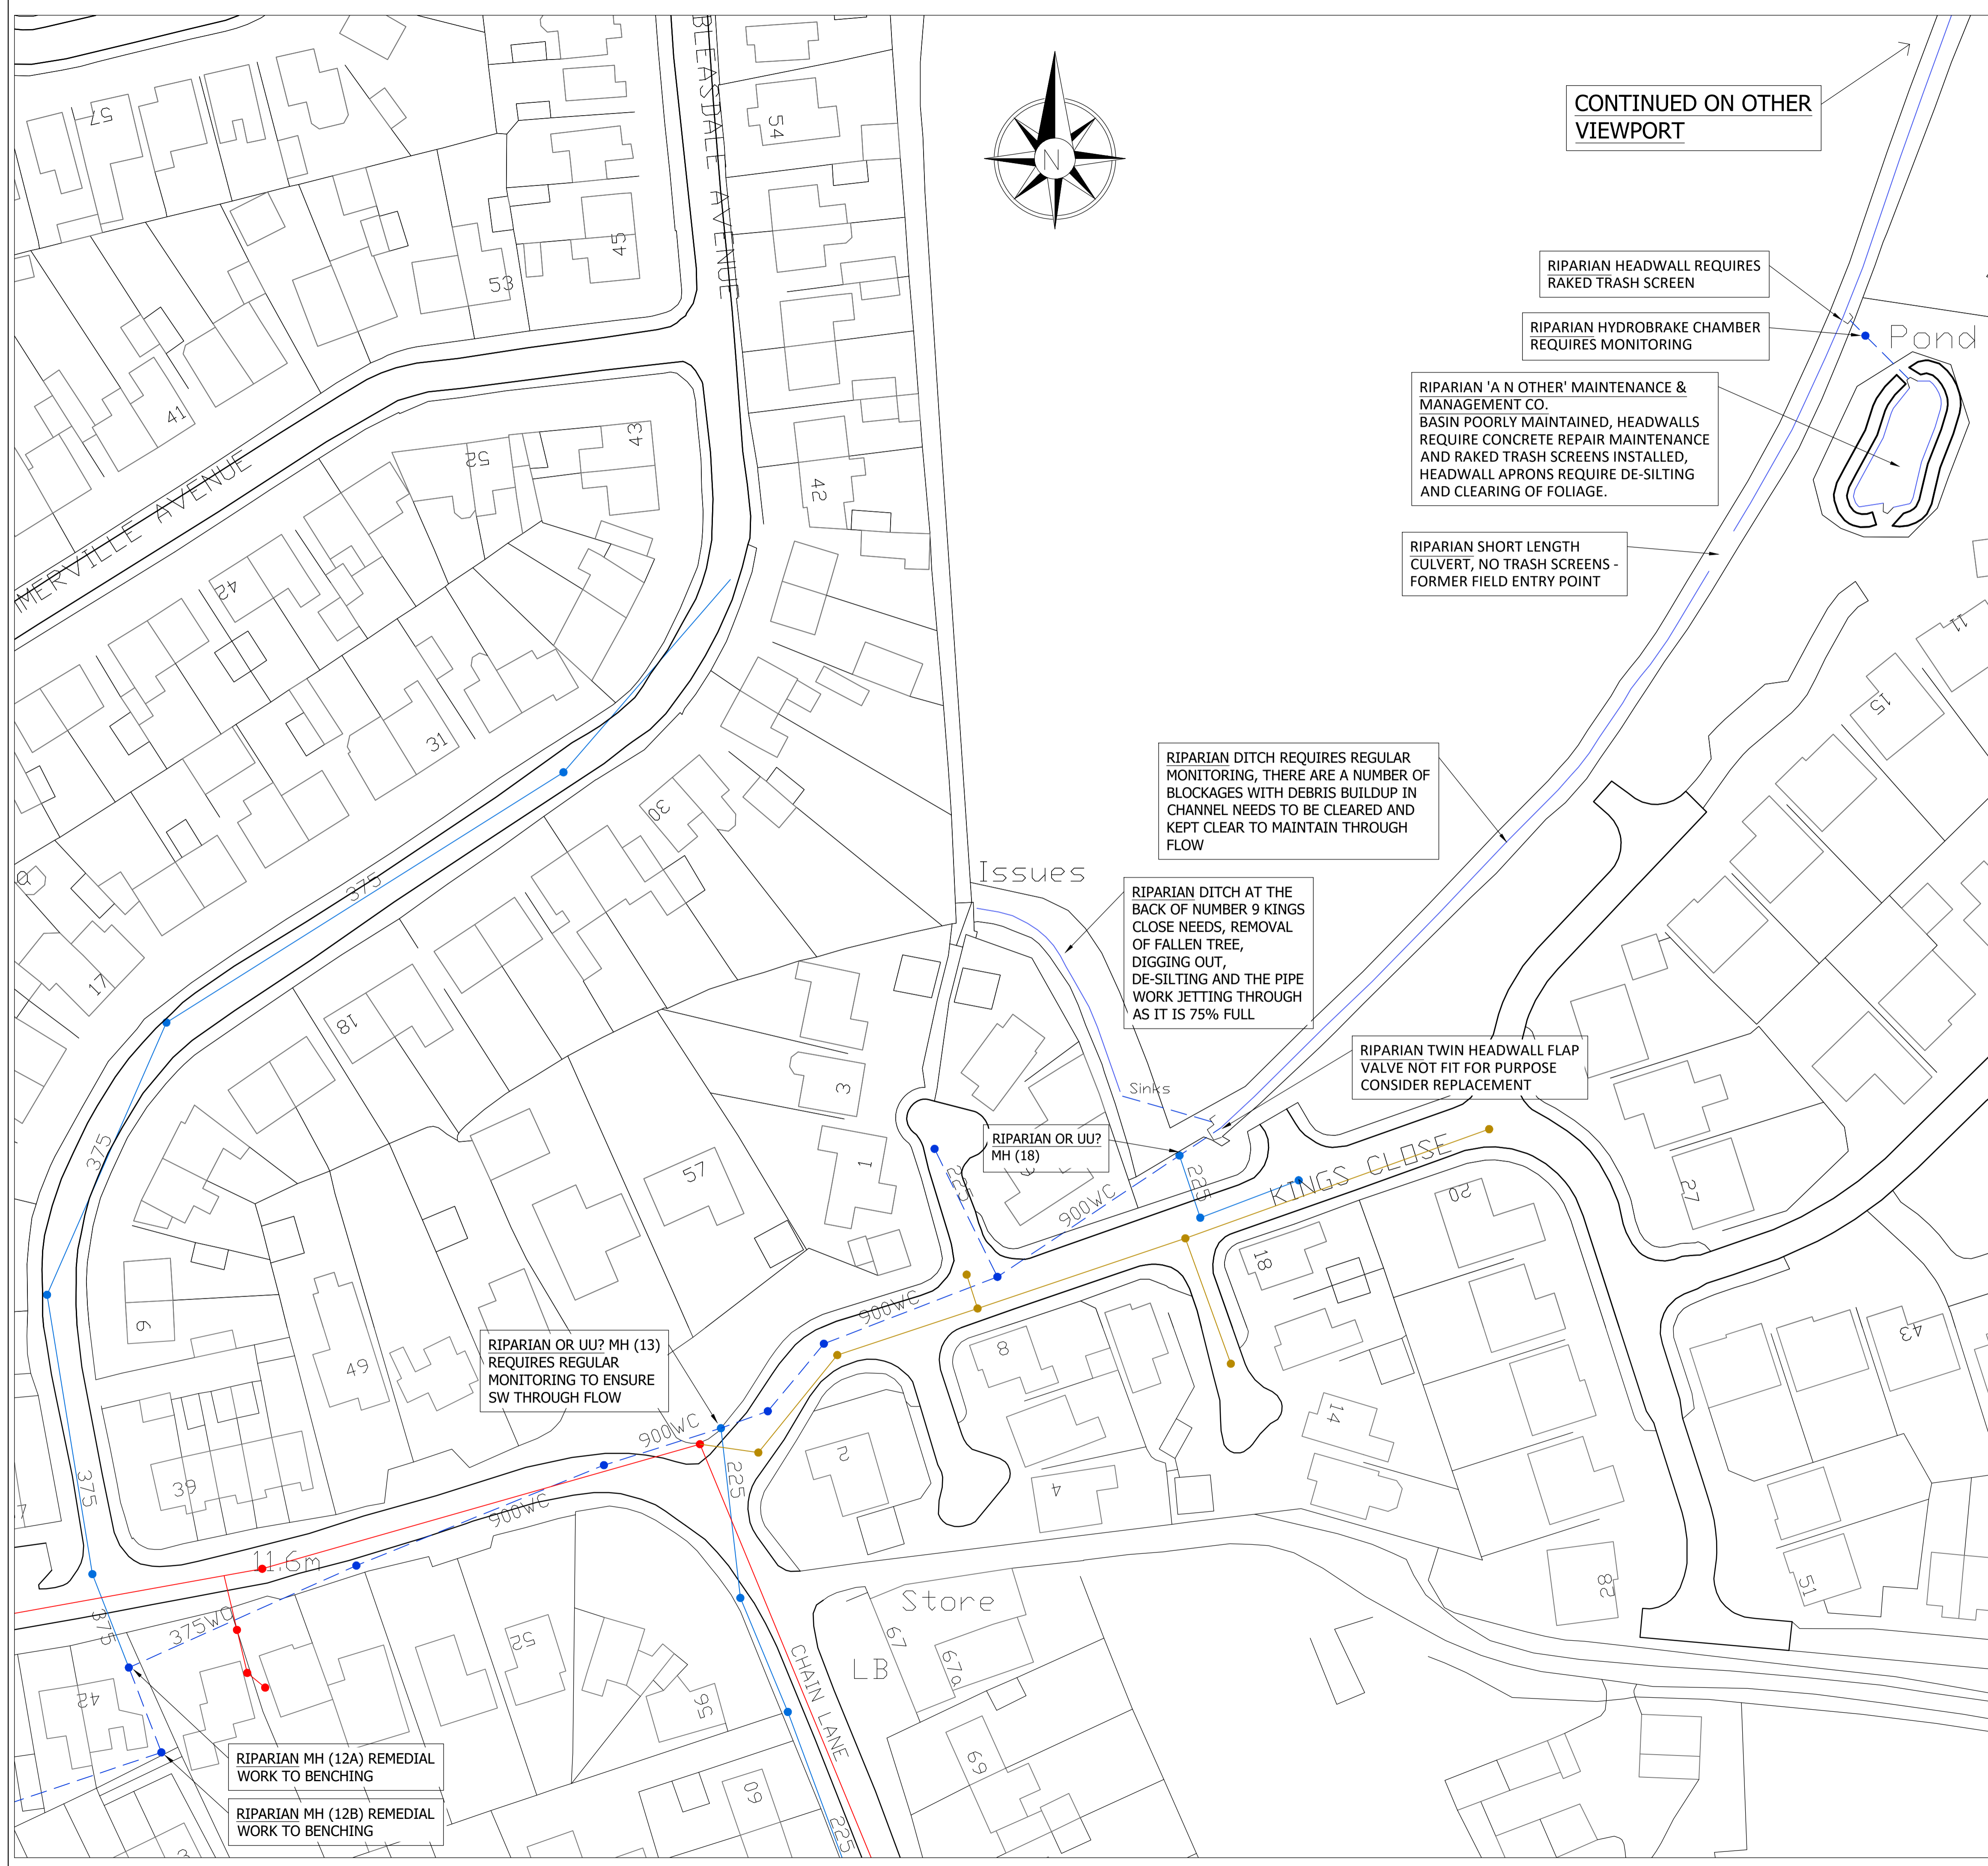
RIPARIAN HEADWALL REQUIRES RAKED TRASH SCREEN

RIPARIAN HYDROBRAKE CHAMBER REQUIRES MONITORING

RIPARIAN 'A N OTHER' MAINTENANCE & MANAGEMENT CO. BASIN POORLY MAINTAINED, HEADWALLS REQUIRE CONCRETE REPAIR MAINTENANCE AND RAKED TRASH SCREENS INSTALLED, HEADWALL APRONS REQUIRE DE-SILTING AND CLEARING OF FOLIAGE.

RIPARIAN SHORT LENGTH CULVERT, NO TRASH SCREENS - FORMER FIELD ENTRY POINT

RIPARIAN DITCH REQUIRES REGULAR MONITORING, THERE ARE A NUMBER OF BLOCKAGES WITH DEBRIS BUILDUP IN CHANNEL NEEDS TO BE CLEARED AND KEPT CLEAR TO MAINTAIN THROUGH FLOW

RIPARIAN DITCH AT THE BACK OF NUMBER 9 KINGS CLOSE NEEDS, REMOVAL OF FALLEN TREE, DIGGING OUT, DE-SILTING AND THE PIPE WORK JETTING THROUGH AS IT IS 75% FULL

RIPARIAN TWIN HEADWALL FLAP VALVE NOT FIT FOR PURPOSE CONSIDER REPLACEMENT

RIPARIAN OR UU? MH (18)

RIPARIAN OR UU? MH (13) REQUIRES REGULAR MONITORING TO ENSURE SW THROUGH FLOW

RIPARIAN MH (12A) REMEDIAL WORK TO BENCHING

RIPARIAN MH (12B) REMEDIAL WORK TO BENCHING

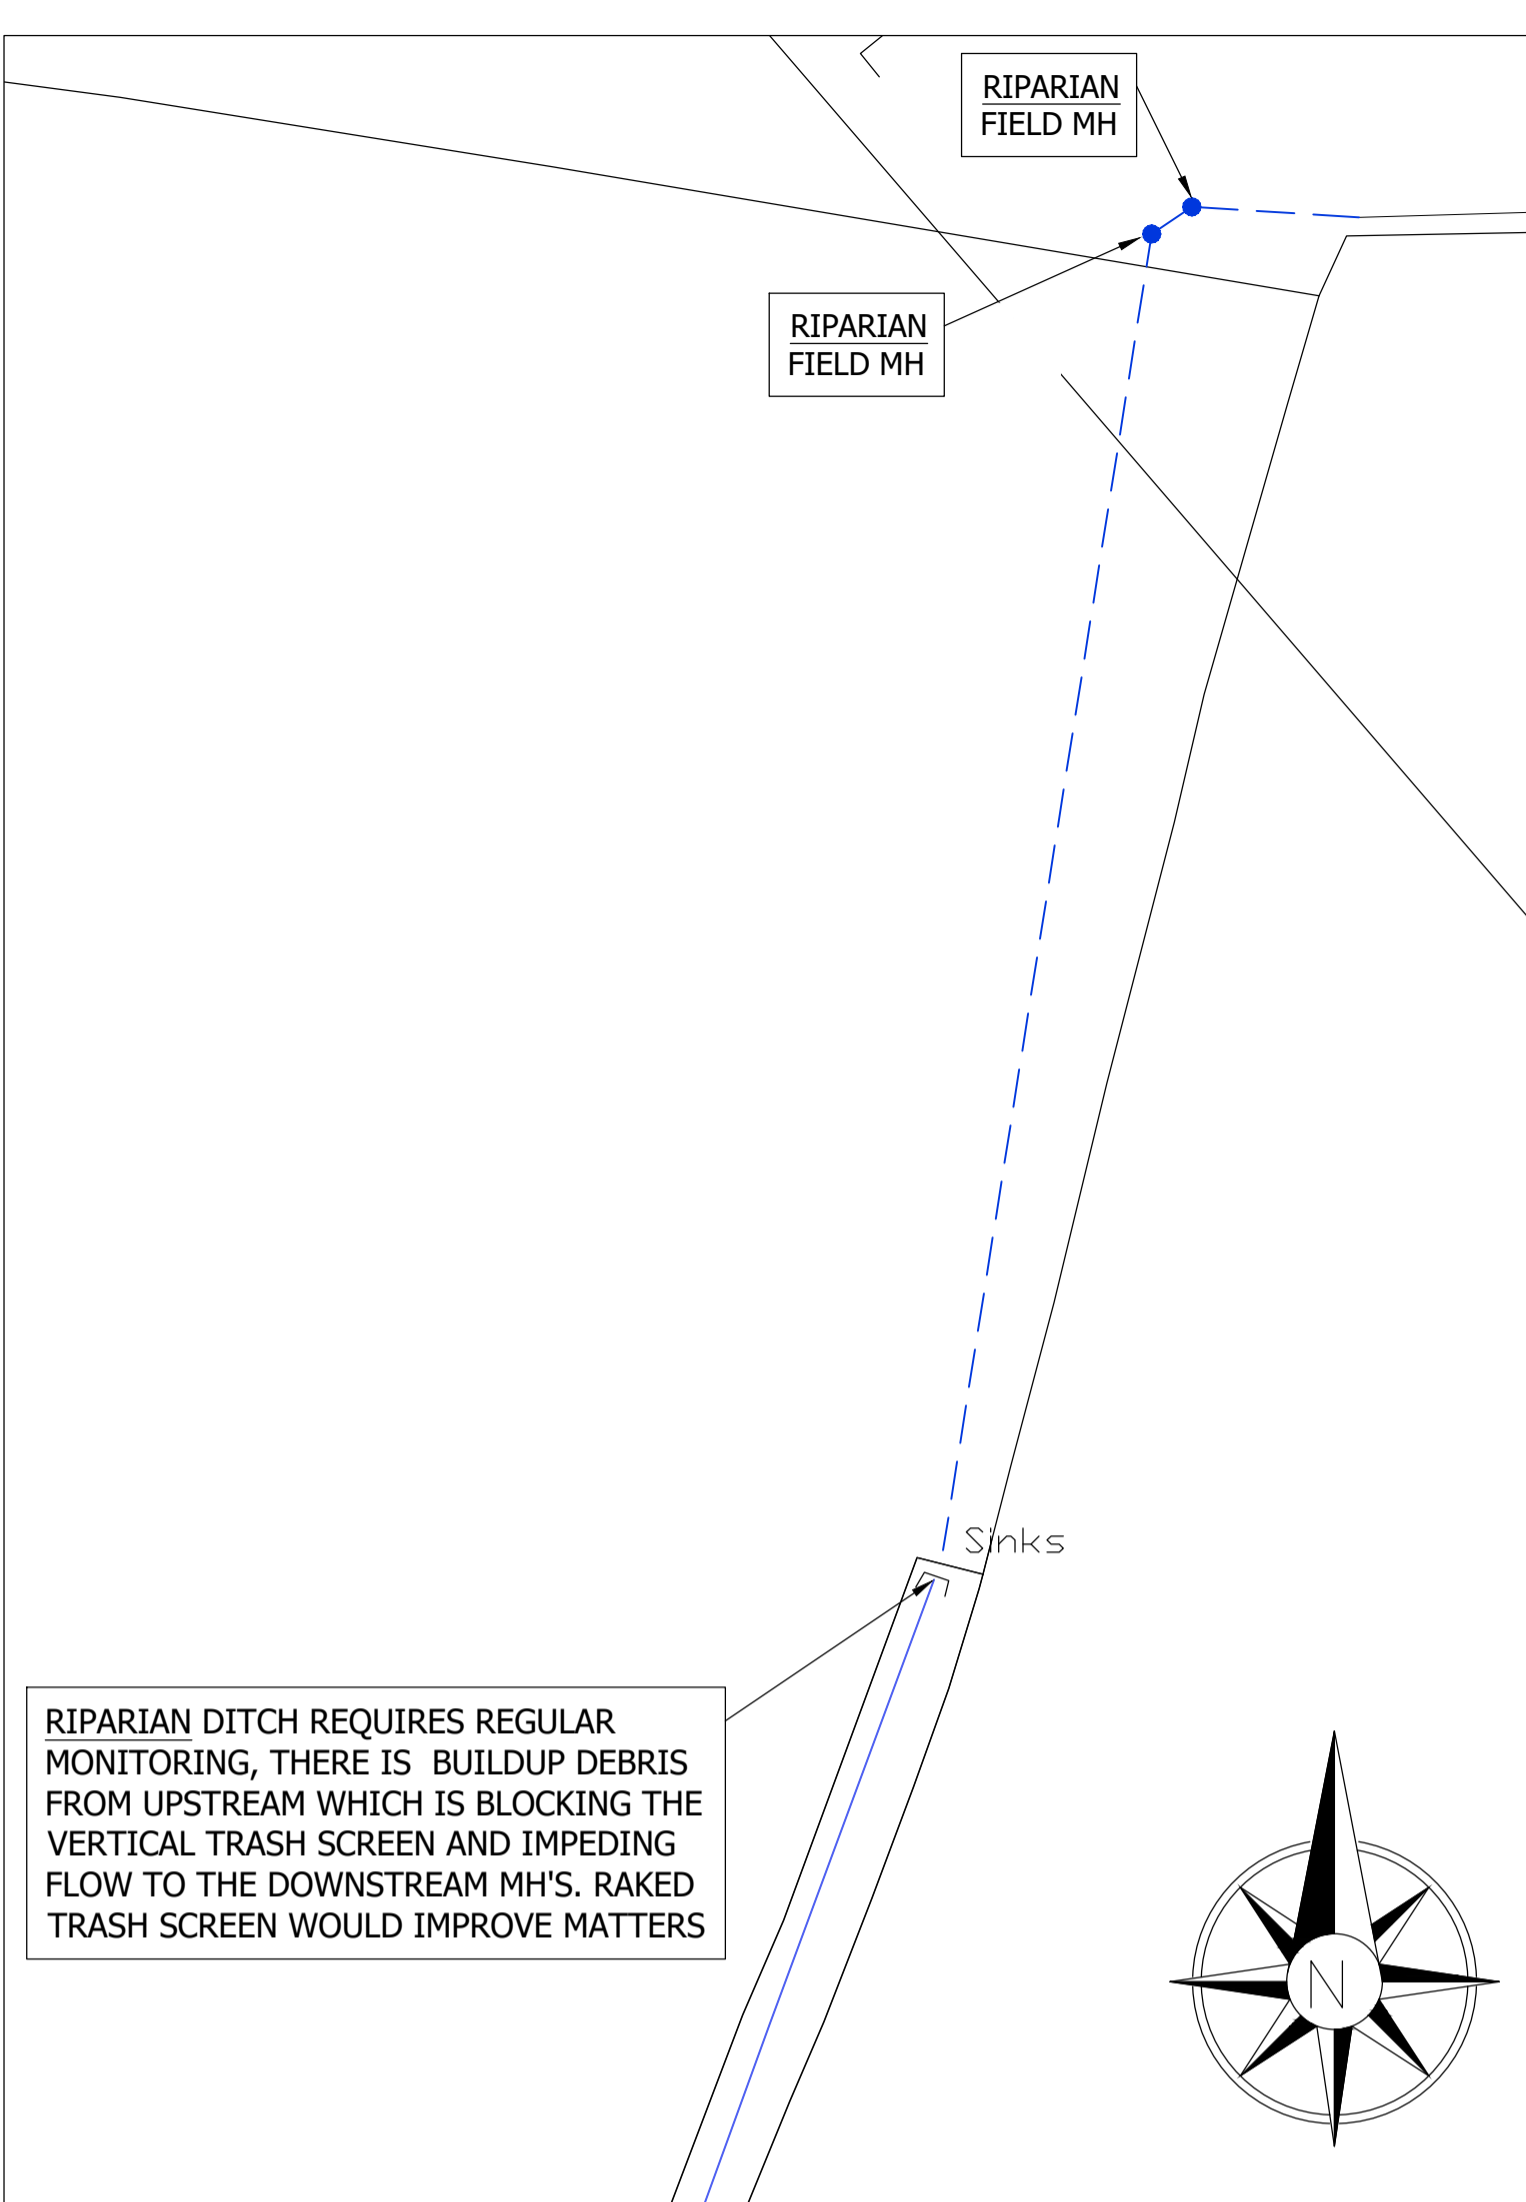
RIPARIAN DITCH REQUIRES REGULAR MONITORING, THERE IS BUILDUP DEBRIS FROM UPSTREAM WHICH IS BLOCKING THE VERTICAL TRASH SCREEN AND IMPEDING FLOW TO THE DOWNSTREAM MH'S. RAKED TRASH SCREEN WOULD IMPROVE MATTERS
