Kirkham Rural Splash

Station Road
Kirkham
Preston
PR4 2HA

Mechanical & Electrical Engineering Services Condition Report & Options Appraisal

REVISION HISTORY			Ref.	1367-R01
Rev.	Author	Checked By	Date	Comments / Status
01	Steven Walley (Mech) Jonathan Baron (Elec)	N/A	04/03/24	First issue.
02	Steven Walley (Mech) Jonathan Baron (Elec)	N/A	20/03/24	Second issue.
03	Steven Walley (Mech) Jonathan Baron (Elec)	N/A	26/03/24	Third issue.
04	Steven Walley (Mech) Jonathan Baron (Elec)	N/A	03/04/24	Fourth issue.

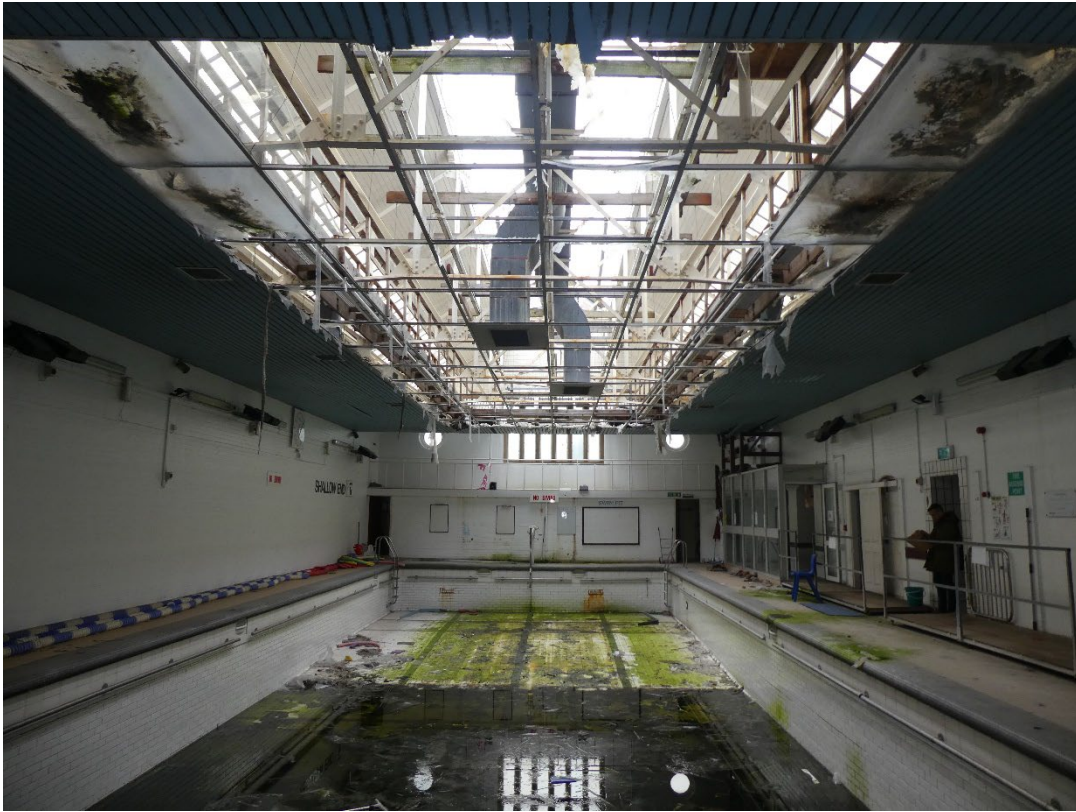
Pool Area Ductwork

The ductwork is generally routed in the roof void. The ductwork appears to be galvanised mild steel. Thermal insulation is applied to the supply ductwork only. Supply air is discharged into the space by a series of ceiling-mounted double deflection grilles. The return air grilles are egg-crate types.

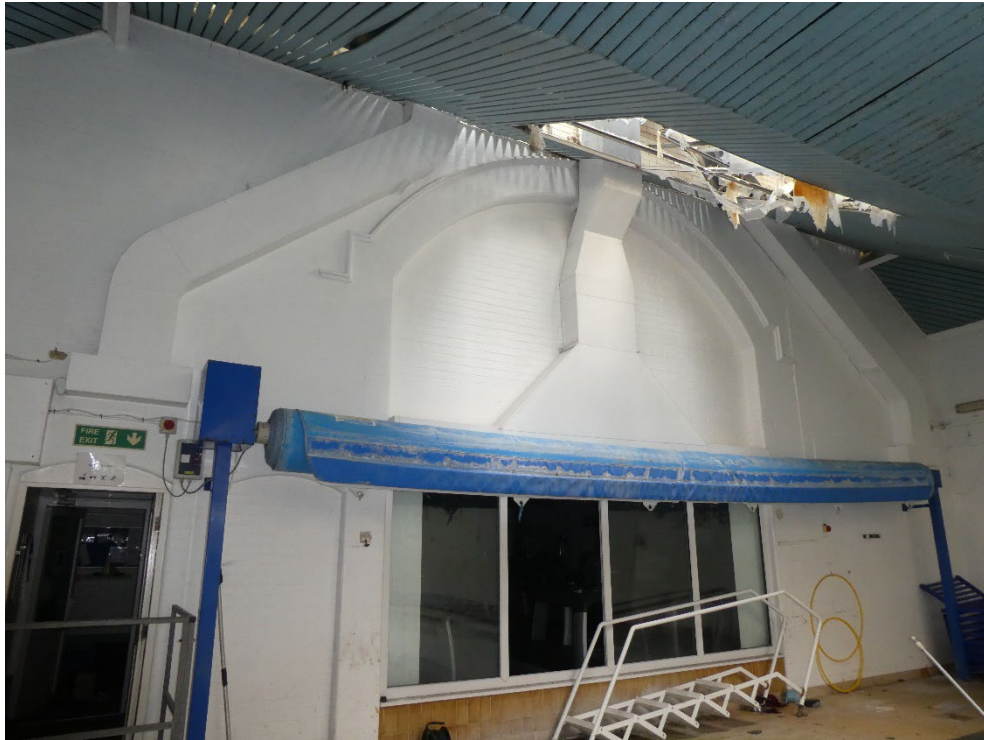
Ductwork Serving the Gym (Routed on the Wall)

The pool ventilation system also serves the adjacent Gym, which is known to have been a learner pool which was filled in to create the current Gym space. The supply and extract ductwork serving the gym is routed down the wall of the main pool area, with supply and extract grilles mounted at high level in the gym.

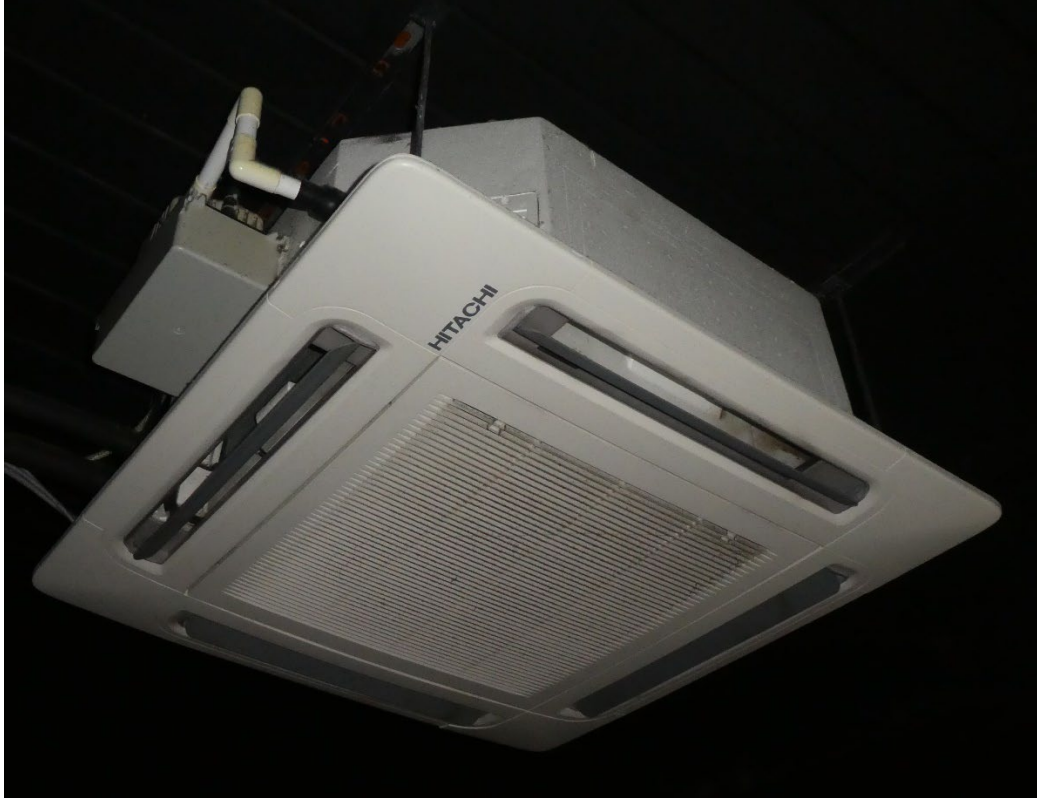
Gym AC Indoor Unit

There are 2 No. Hitachi ceiling cassette units installed in the space, each with condensate lift pump. The associated outdoor units are located externally, fixed at high level using cantilever brackets on the northern wall of the Gym. The data plate on the outdoor units indicates a manufacturing date of 2000. The systems use refrigerant type R410.

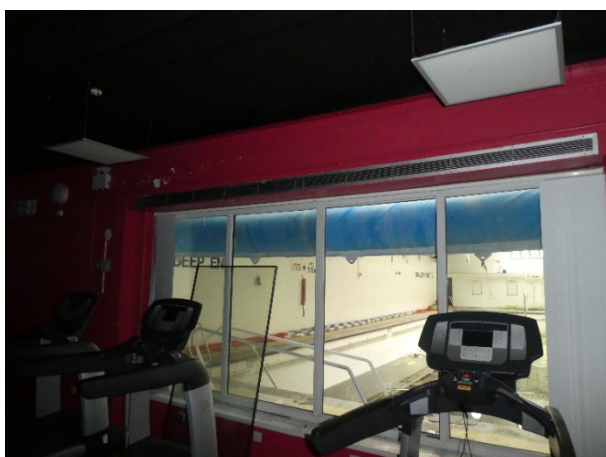
Gym Lighting

The general lighting within the building is a combination of LED lighting, Florescent Lighting and Metal Halide Floods. The changing & gym area has some modern LED Lighting and appears to be circa 7+ years old.

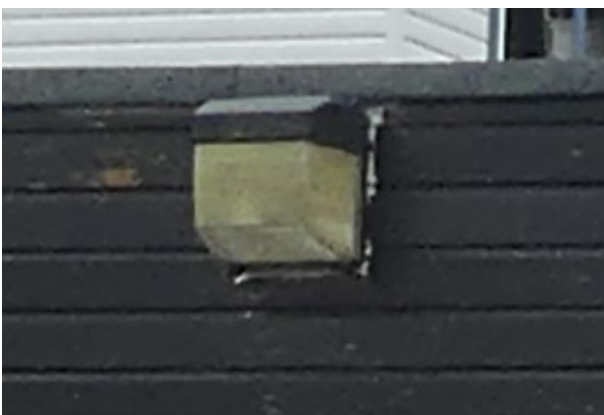
External Lighting 1

The External lighting was tested to be operational the time of the survey, however on visual inspection the existing luminaires used a combination of LED flood lights, Metal Halide wall lights & Fluorescent circular bulkheads. Generally, the installation was poor with cabling clipped to the external faced of the building in a poor manor, as part of the works new shall be installed with all cables installed internally where possible therefore removing the need for externally clipped cabling and thus tidying up the building.

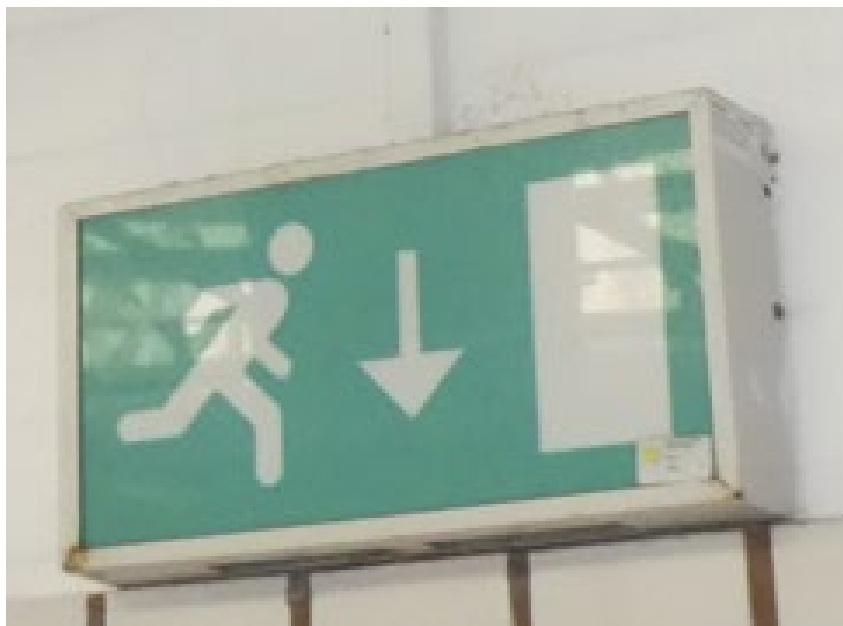
Typical Emergency Exit Luminaire

The emergency lighting was observed to be self-contained luminaires with individual battery packs. The installation was not functional during the survey with evidence of water ingress in some fittings.

Following the full deep discharge of the batteries since the closure and isolation of lighting circuits, the luminaires will be beyond recovery and will require a full replacement.

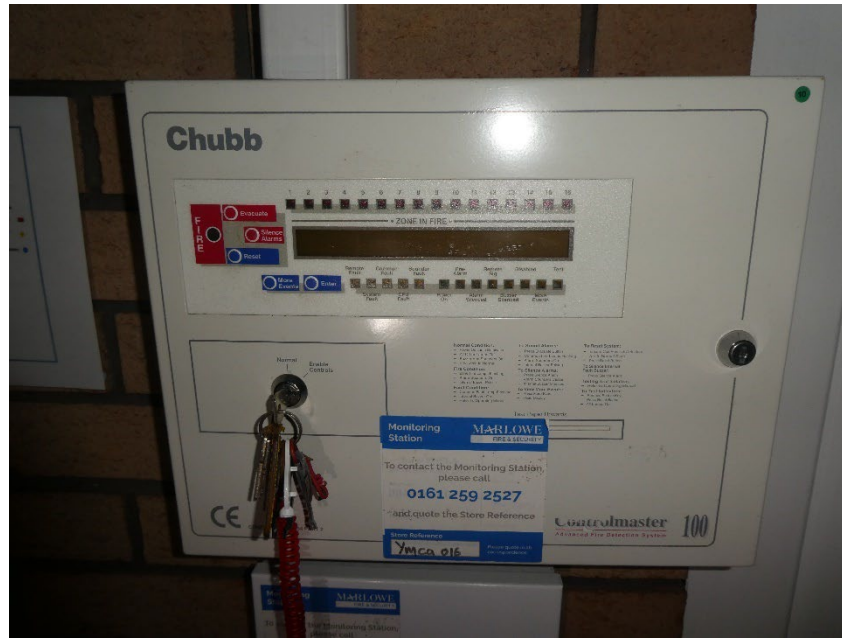
Existing Fire Alarm Panel

The fire alarm is an addressable CHUBB Advanced Control Master 100 system with an estimated manufacturing date of 2007, the main panel is located in the reception circulation area. Detection is automated with manual call points installed at relevant locations. The system was non-operational at the time of the survey, due to the age of the system and parts being unavailable for an obsolete system; the panel, wiring and devices should be replaced as part of the refurbishment works.
